## Restoration Log

### Aston Martin DB6 MKI Vantage

Aston Workshop, Red Row, Beamish, County Durham, DH9 0RW, England.

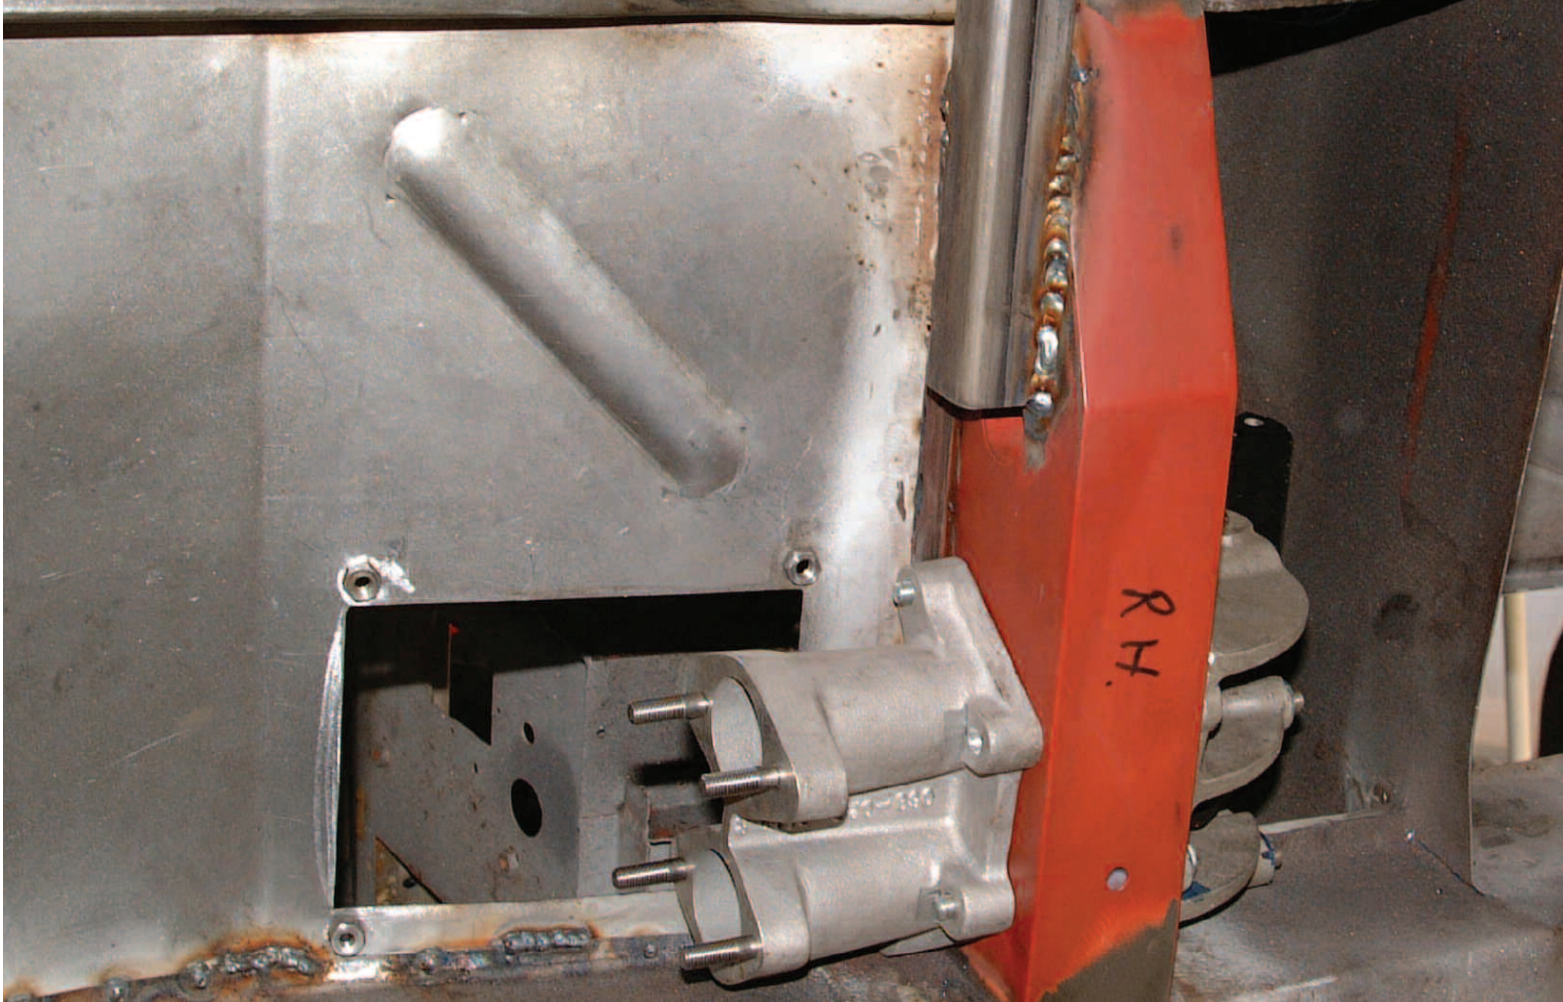
case, the outer forlorn state of the car was perhaps also an accurate indicator of its inner state, which was poor.

Not only were the sills showing an advanced state of decay but also the front outriggers, the rear chassis legs and a boot floor that showed more resemblance to lace than something solid. The rear suspension anchorages were equally unsound.

At the front, the base of the front foot wells, the front engine bulkhead and cross member was also heavily rust damaged, as were the under-bonnet side panels.

The chassis reconstruction involved repairs to almost every section and panel below the top of the A and B posts. Important structures replaced in toto involved the sills, offside and near side front outriggers, a large section of the chassis leading back from the front cross member and which supports the front suspension and new jacking points. At the rear, virtually the complete rear suspension supporting structure required to be replaced, as well as the support legs leading backwards to support the boot floor. Within the bonnet area, not only did the panels either side of the bonnet require replacement, but also all of the forward structure from the front suspension uprights back to the engine bulkhead. Sections of the front bulkhead showed significant deterioration and rust damage and areas had to be cut out and replaced. All of the floor sections had to be replaced and welded into place, as also the rear seat pan, which had been holed.
