Restoration Log

Aston Martin DB6 MKI

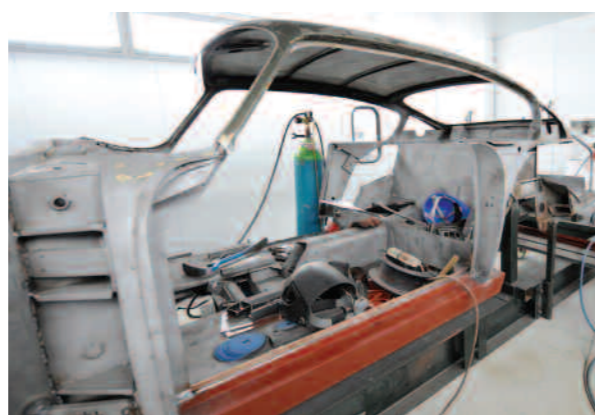
Once this was been done, the outer aluminium sills were removed, and the chassis was then cleaned back to remove all of the residual oil, grease and general muck that had accumulated, of which there was a huge amount. This was a filthy job, but vital if the grit blast of the structure that followed was to be fully effective in removing all of the surface rust. It was only when the grit blast was completed that it became possible to acquire an indicative assessment of the chassis structure that lay underneath. Early assessments of the structure indicated that in this

case, the outer forlorn state of the car was perhaps also an accurate indicator of its inner state, which was poor.

Not only were the sills showing an advanced state of decay but also the front outriggers, the rear chassis legs and a boot floor that showed more resemblance to lace than something solid. The rear suspension anchorages were equally unsound.

At the front, the base of the front foot wells, the front engine bulkhead and cross member was also heavily rust damaged, as were the under-bonnet side panels.

The chassis reconstruction involved repairs to almost every section and panel below the top of the A and B posts. Important structures replaced in toto involved the sills, offside and near side front outriggers, large section of the chassis leading back from the front cross member and which supports the front suspension and new jacking points. At the rear, virtually the complete rear suspension supporting structure required to be replaced, as well as the support legs leading backwards to support the boot floor. Within the bonnet area, not only did the panels either side of the bonnet require replacement, but also all of the forward structure from the front suspension uprights back to the engine bulkhead. Sections of the front bulkhead showed significant deterioration and rust damage and areas had to be cut out and replaced. All of the floor sections had to be replaced and welded into place, as also the rear seat pan, which had been holed.

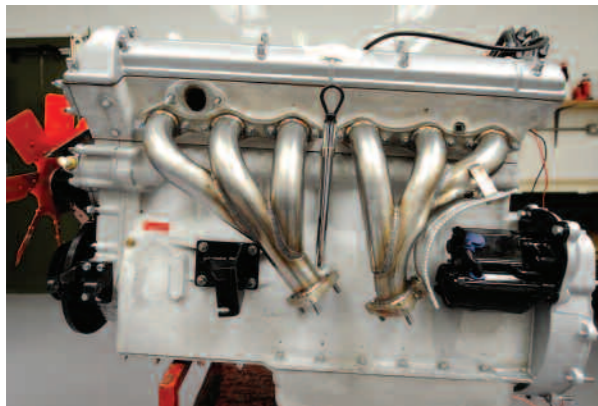
As this car was to be totally restored, the next stage was to remove pistons and connecting rods, followed by the crankshaft, oil pump and strainer assembly and all of external fittings. The cylinder block was next inserted into an oven and heated, followed by the extraction of all cylinder liners. This revealed that the seatings for the liners though damaged, could be recovered. A check across all main bearing webs revealed no serious cracking. This meant that, subject to recovering the sound condition of the liner seatings, the block could be safely cleaned and reused.

The crankshaft was carefully measured across all main bearing and connecting rod journals, and though a small

amount of wear was noted, this was well within acceptable tolerances and therefore indicated that the crankshaft could be safely reground, polished and refitted with oversize bearing shells.
