# Aston Workshop

## Restoration Log

Aston Martin DB2 Chassis no. LML 50/186

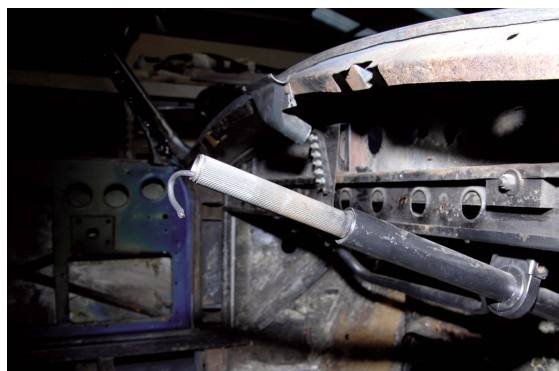
The chassis was fabricated from high quality tubular steel and it too suffered inevitable corrosion, although in the case of this car, there was little remedial work required. However, significant parts of the floor were found to be corroded and would need to be replaced.

At the front, the base of the front foot wells, the front engine bulkhead and cross member was also heavily rust damaged, as were the under-bonnet side panels. Stripping the many layers of paint from the body shell followed, revealing a considerable amount of old panel damage. Corrosion in all of the usual spots was found around the wheel arches, sill, around the bonnet and across the rear of the car, around the bottom of the boot, all caused through damp and the effects of electrolytic induced corrosion of the aluminium panel in the proximity of its steel supporting frame.

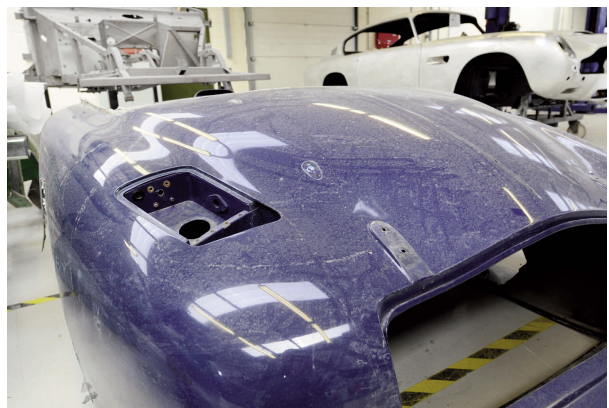
The area of greatest need was around the rear body. Not only was there advanced corrosion but 50 years of history, bumps and scrapes, dents and other accumulated blemishes.

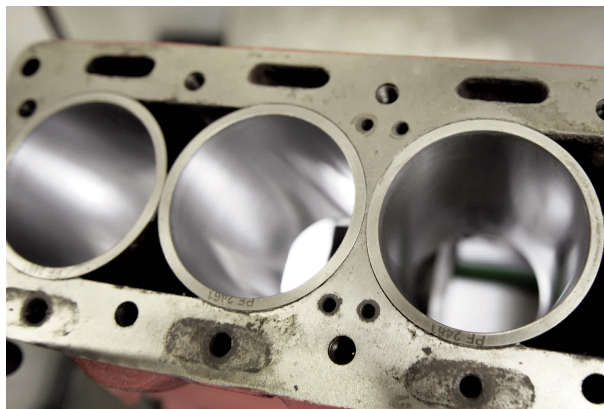
After removal from the Aston, the engine and gearbox unit was thoroughly steam cleaned before any work was carried out.

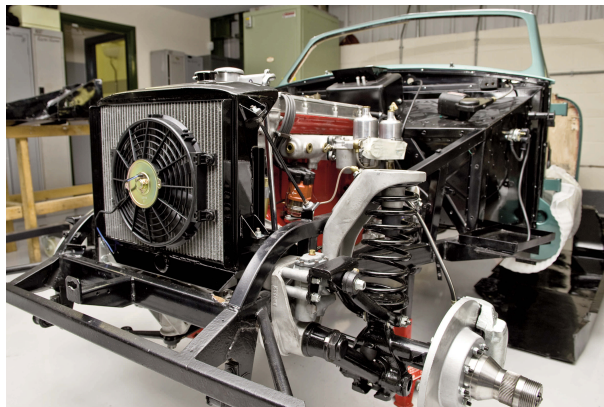
Starting with the bare chassis and body, the first items to be installed were the brake and fuel lines. Extreme care was taken to ensure that these were all precisely aligned and neatly installed as the quality of this work distinguishes a restoration of the highest quality from those that just aspire to be good. The next stage was the fitting of the front and rear suspension, wheel hubs and steering linkages and the steering box. At this point the car was fitted with some “slave” wheels and became mobile.
