Restoration Log

Aston Martin DB6 MKI Vantage

Aston Workshop, Red Row, Beamish, County Durham, DH9 0RW, England.

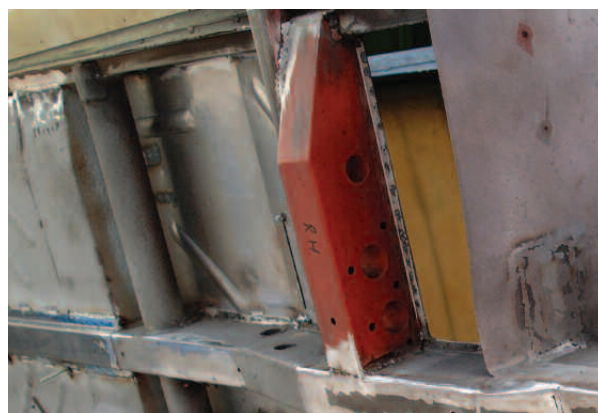
So as part of this assessment, the shell was removed in two halves, the rear structure that runs from the B Post backwards and the front section that runs forward from the A Post. The front shell was separated at the base of the windscreen pillar and the rear section halfway up the rear window in line with the rear window and quarter-light. The front skin was unclenched from around the frame that surrounds the bonnet aperture together with the base of the windscreen frame. At the rear, the boot aperture and rear window frame provide the principal anchorages and the skin was unclenched from that also.

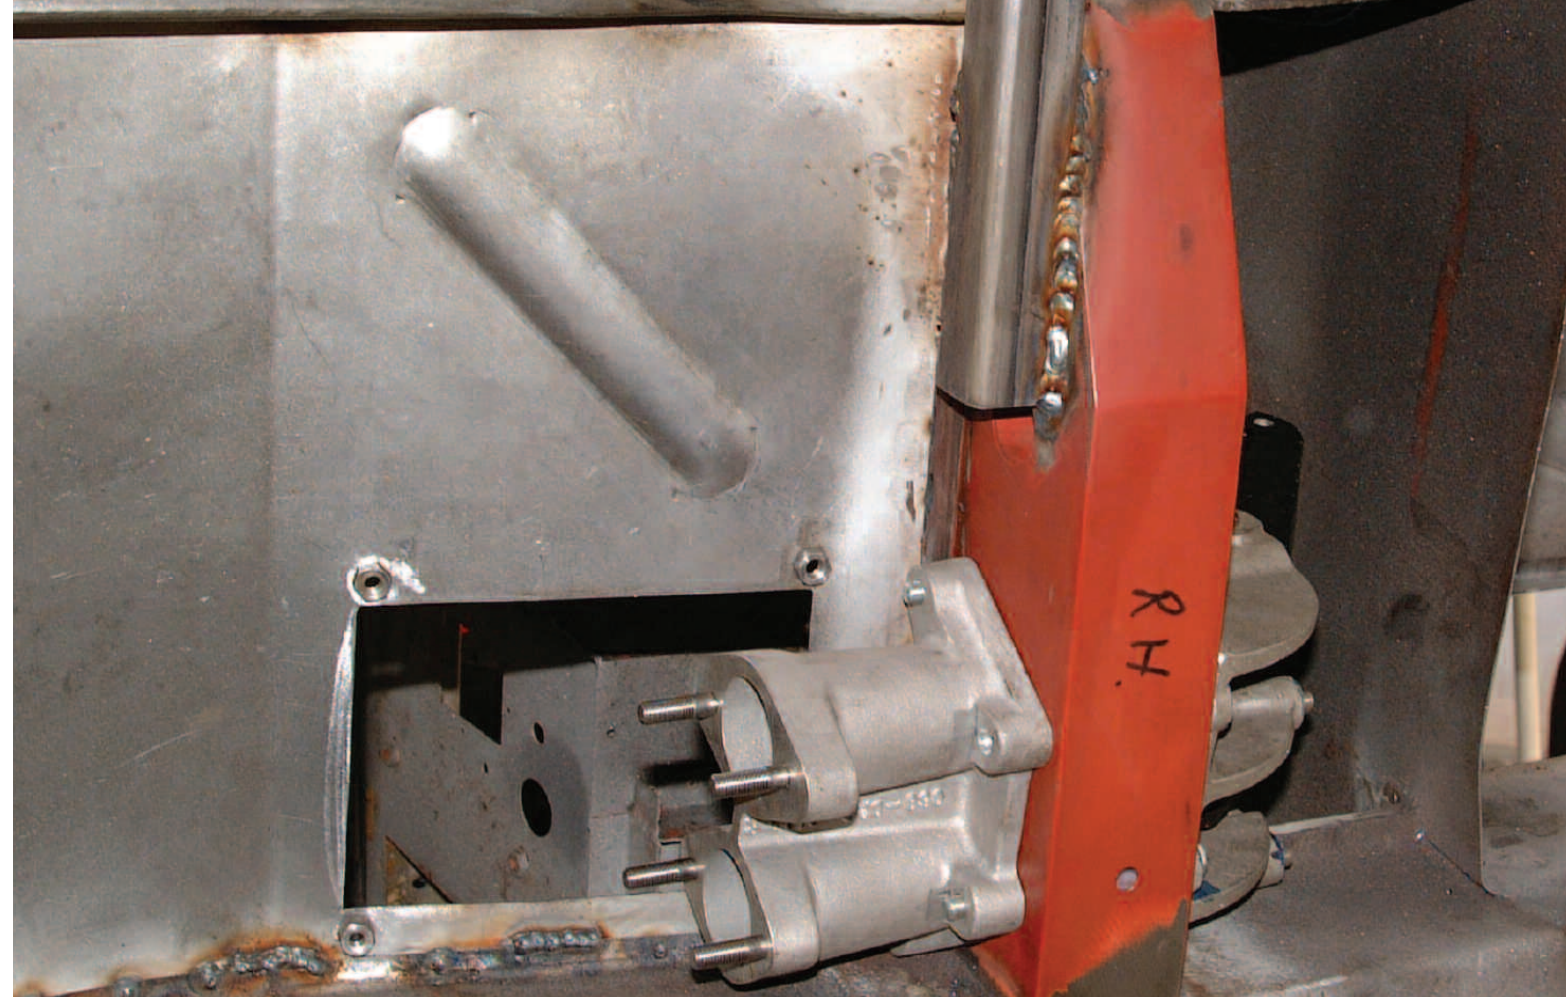
case, the outer forlorn state of the car was perhaps also an accurate indicator of its inner state, which was poor.

Not only were the sills showing an advanced state of decay but also the front outriggers, the rear chassis legs and a boot floor that showed more resemblance to lace than something solid. The rear suspension anchorages were equally unsound.

At the front, the base of the front foot wells, the front engine bulkhead and cross member was also heavily rust damaged, as were the under-bonnet side panels.

The chassis reconstruction involved repairs to almost every section and panel below the top of the A and B posts. Important structures replaced in toto involved the sills, offside and near side front outriggers, a large section of the chassis leading back from the front cross member and which supports the front suspension and new jacking points. At the rear, virtually the complete rear suspension supporting structure required to be replaced, as well as the support legs leading backwards to support the boot floor. Within the bonnet area, not only did the panels either side of the bonnet require replacement, but also all of the forward structure from the front suspension uprights back to the engine bulkhead. Sections of the front bulkhead showed significant deterioration and rust damage and areas had to be cut out and replaced. All of the floor sections had to be replaced and welded into place, as also the rear seat pan, which had been holed.
