Aston Workshop

Restoration Log

Aston Martin DB2 Chassis no. AM 300/1199

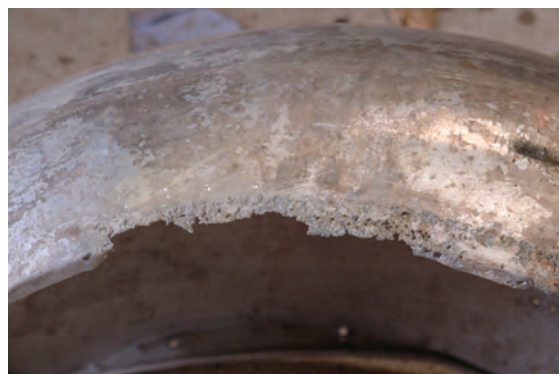
The chassis was fabricated from high quality tubular steel and it too suffered inevitable corrosion, although in the case of this car, there was little remedial work required. However, significant parts of the floor were found to be corroded and would need to be replaced.

At the front, the base of the front foot wells and the front engine bulkhead was also heavily rust damaged. All these areas would be replaced with new metal. Stripping the many layers of paint from the body shell followed, revealing a considerable amount of old panel damage. Corrosion in all of the usual spots was found around the wheel arches, sill, around the bonnet and across the rear of the car, around the bottom of the boot, all caused through damp and the effects of electrolytic induced corrosion of the aluminium panel in the proximity of its steel supporting frame.

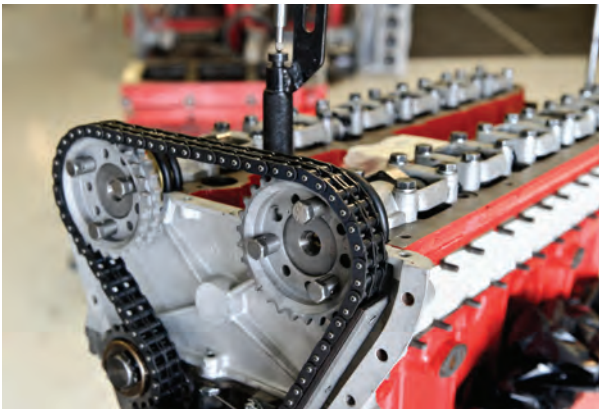
In the light of past experience, The Aston Workshop does not do partial re-builds of DB2 engines, even if there is evidence of a recent re-build by some other specialist. After removal from the Aston, the engine and gearbox unit was thoroughly steam cleaned before any work was carried out.

The gearbox, complete with bellhousing, was removed and put into storage as it was to be replaced with a modern 5 speed unit.
