Aston Workshop

Restoration Log

Aston Martin DB6
MK2 /4291/L

Engine no.400/4685/SVC

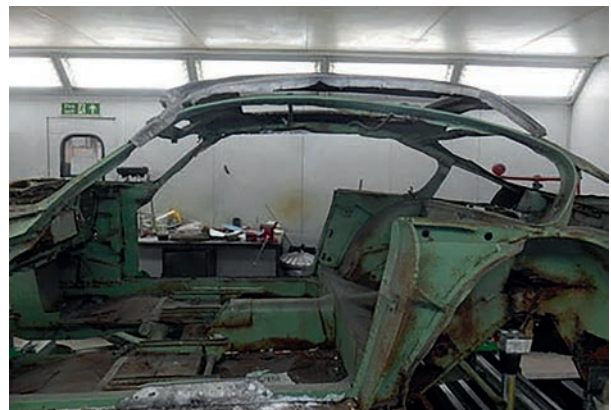
Early assessments of the structure indicated that in this case, the forlorn state of the chassis was perhaps also an accurate indicator of its inner state, which following internal camera inspection of the box sections was poor. Not only were the sills showing an advanced state of decay but also the front outriggers, the rear chassis legs and a boot floor that showed more resemblance to lace than something solid. The rear suspension anchorages were equally unsound. At the front, the base of the front foot wells, the front engine bulkhead and cross member were also heavily rust damaged, as were the under-bonnet side panels.

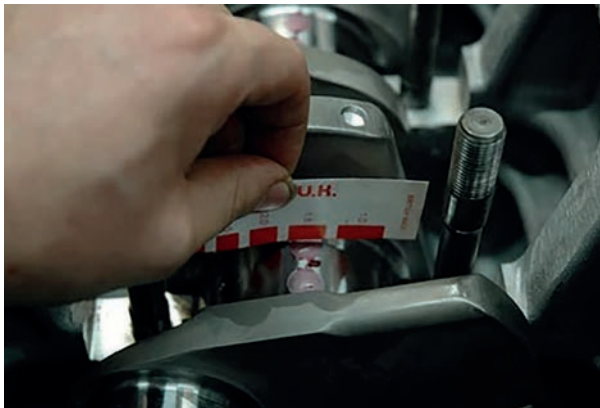
As this engine was to be totally restored, the next stage was to remove pistons and connecting rods followed by the crankshaft, oil pump and strainer assembly and all the external fittings. The cylinder block was next inserted into an oven and heated, followed by the extraction of all cylinder liners. This revealed that the seatings for the liners, though damaged by age and corrosion, could be recovered by welding and machining, thus retaining an original matching numbers engine to live with the original rebuilt chassis.

A check across all main bearing webs revealed no serious cracking. This meant that, subject to recovering the sound condition of the liner seatings, the block could be safely cleaned and reused. The crankshaft was carefully measured across all main bearing and connecting rod journals, and though a small amount of wear was noted the option was taken to install a new LD15 upgraded crankshaft providing a smoother running engine with the advantage of a lip seal to the rear journal and a new upgraded front damper.
