# Aston Workshop

## RESTORATION LOG DB6/2914/R

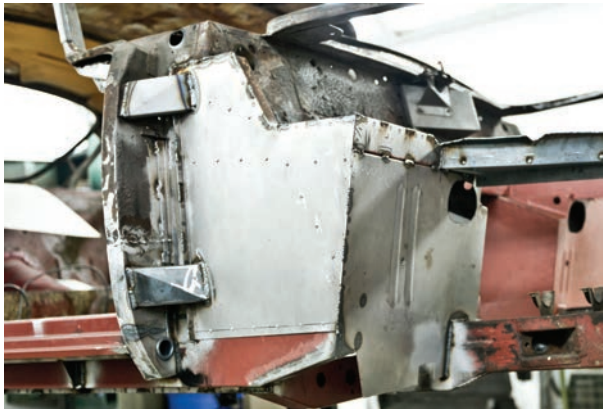
So as part of this assessment, the shell was removed in two halves, the rear structure that runs from the B Post backwards and the front section that runs forward from the A Post. The front shell was separated at the base of the windscreen pillar and the rear section halfway up the rear window in line with the rear window and quarter-light. The front skin was unclenched from around the frame that surrounds the bonnet aperture together with the base of the windscreen frame. At the rear, the boot aperture and rear window frame provide the principal anchorages and the skin was unclenched from that also.

Not only were the sills showing an advanced state of decay but also the front outriggers, the rear chassis legs and a boot floor that showed more resemblance to lace than something solid. The rear suspension anchorages were equally unsound.

At the front, the base of the front foot wells, the front engine bulkhead and cross member was also heavily rust damaged, as were the under-bonnet side panels.

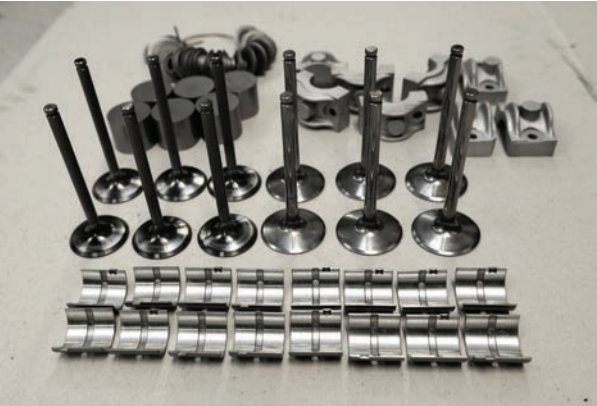
With the engine, gearbox and final drive now separated from the car, these were cleaned off and the engine was dismantled, with the first task being to remove all intake and exhaust manifolds, alternator, water pump and fan. This was followed by the separation of the bell housing and gearbox. The next operation was the removal of the cylinder head. The sump was then removed followed by the removal of the front timing case and chain, the oil pump and filter housing. The separation of the cylinder head followed, revealing for the first time the inner state of the cylinders and pistons.

As this car was to be totally restored, the next stage was to remove pistons and connecting rods, followed by the crankshaft, oil pump and strainer assembly and all of external fittings. The cylinder block was next inserted into an oven and heated, followed by the extraction of all cylinder liners. This revealed that the seatings for the liners though damaged, could be recovered. A check across all main bearing webs revealed no serious cracking. This meant that, subject to recovering the sound condition of the liner seatings, the block could be safely cleaned and reused.
