Restoration Log

Aston Martin DB5 /2263/R Chassis no.
Engine no.400/2277

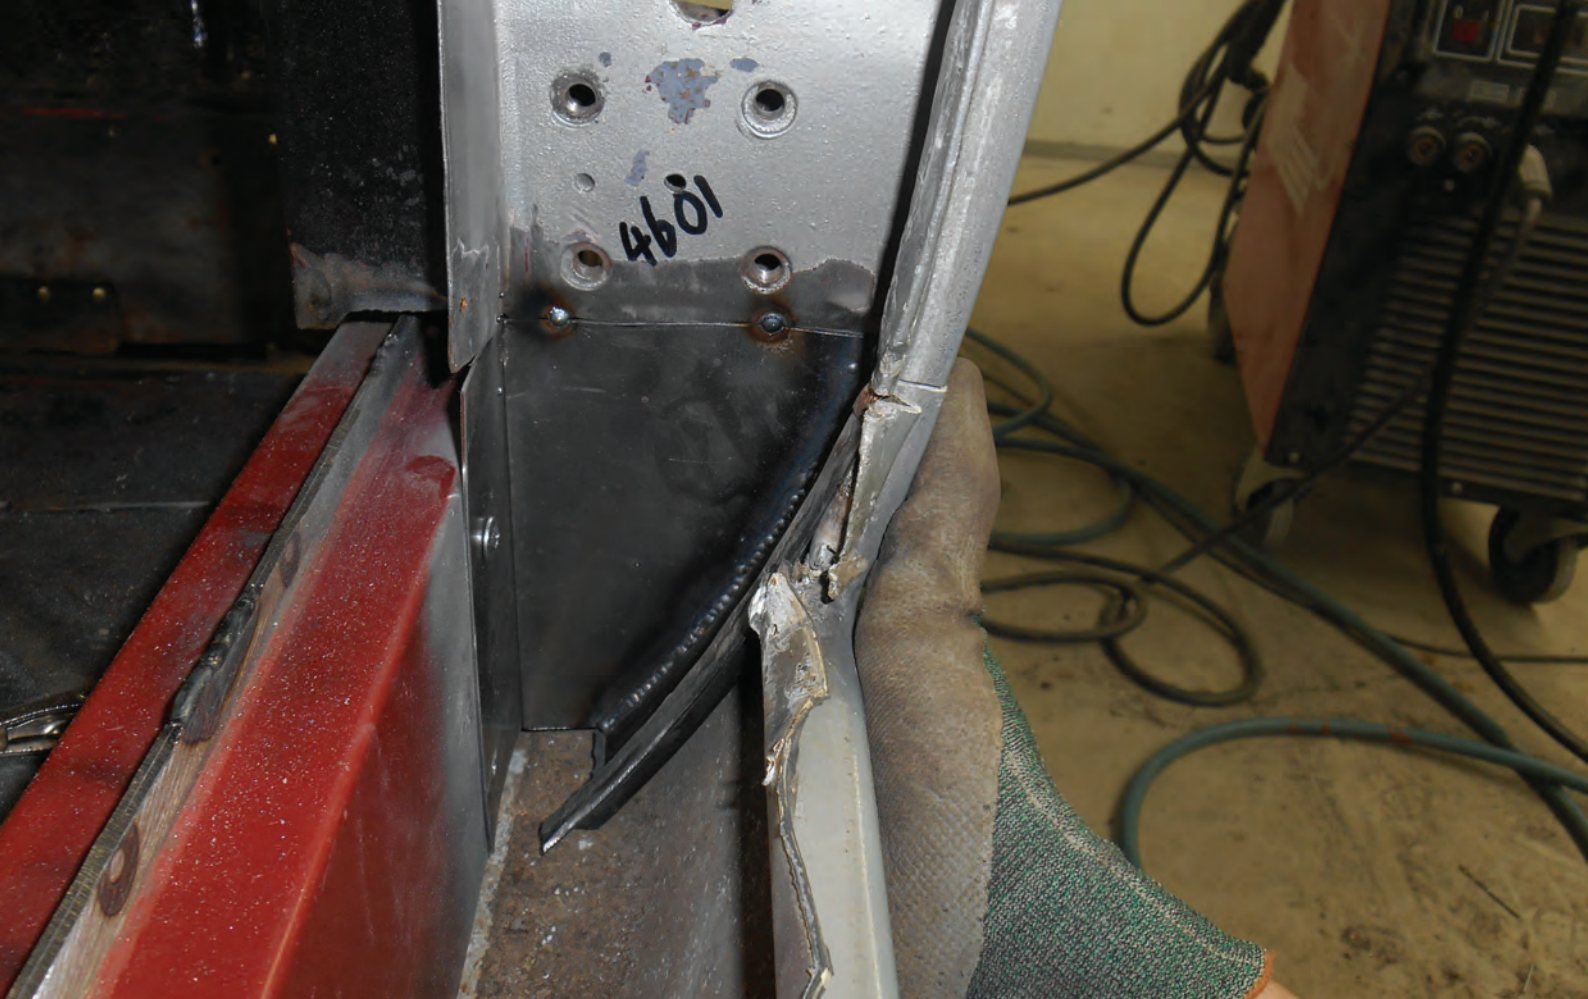
case, the outer condition was perhaps not an accurate indicator of its inner state, which boasted a previous refurbishment but was in fact in poor condition.

Not only were the sills showing an advanced state of decay but also the front outriggers, the rear chassis legs and a boot floor that showed more resemblance to lace than something solid. The rear suspension anchorages were equally unsound.

At the front, the base of the front door posts, the front engine bulkhead and cross member was also heavily rust damaged, as were the under-bonnet side panels.

The chassis reconstruction involved repairs to almost every section and panel below the top of the A and B posts. Important structures replaced in toto involved the sills, offside and near side front outriggers, a large section of the chassis leading back from the front cross member and which supports the front suspension and new jacking points. At the rear, virtually the complete rear suspension supporting structure required to be replaced, as well as the support legs leading backwards to support the boot floor. Within the bonnet area, not only did the panels either side of the bonnet require replacement, but also all of the forward structure from the front suspension uprights back to the engine bulkhead. Sections of the front bulkhead showed significant deterioration and rust damage and areas had to be cut out and replaced as well as some floor sections had to be replaced and welded into place.

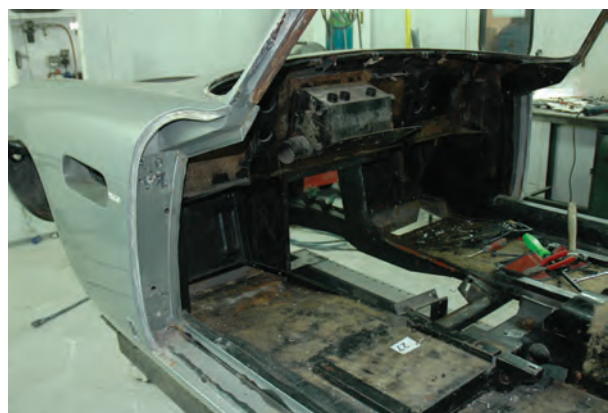
The doors were equally in a poor state and needed a total reconstruction. The doors on these cars suffer most from the rotting out of the door bottoms. In turn this allows the door to twist and in advanced cases, the door hinge members start to break away and the door sags. There is no other alternative to a full reconstruction, but the frame can only be completed and the door skin clenched onto the doorframe once the front and rear body skins have been repaired and remounted.

The bonnet skin also showed signs of delamination, quite common with unrestored cars.

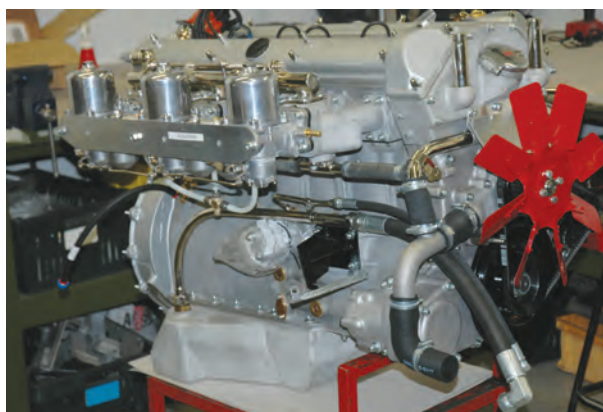
As this car was to be totally restored, the next stage was to remove pistons and connecting rods, followed by the crankshaft, oil pump and strainer assembly and all of the external fittings. The cylinder block was next inserted into an oven and heated, followed by the extraction of all cylinder liners. This revealed that the seatings for the liners showed historic welds and cracks. A check across all main bearing webs revealed historic cracking. This meant that, the way forward was to install a new cylinder block.
