Aston Workshop

Aston Martin DB2/4 Vignale Chassis no. LML/802

The Restoration

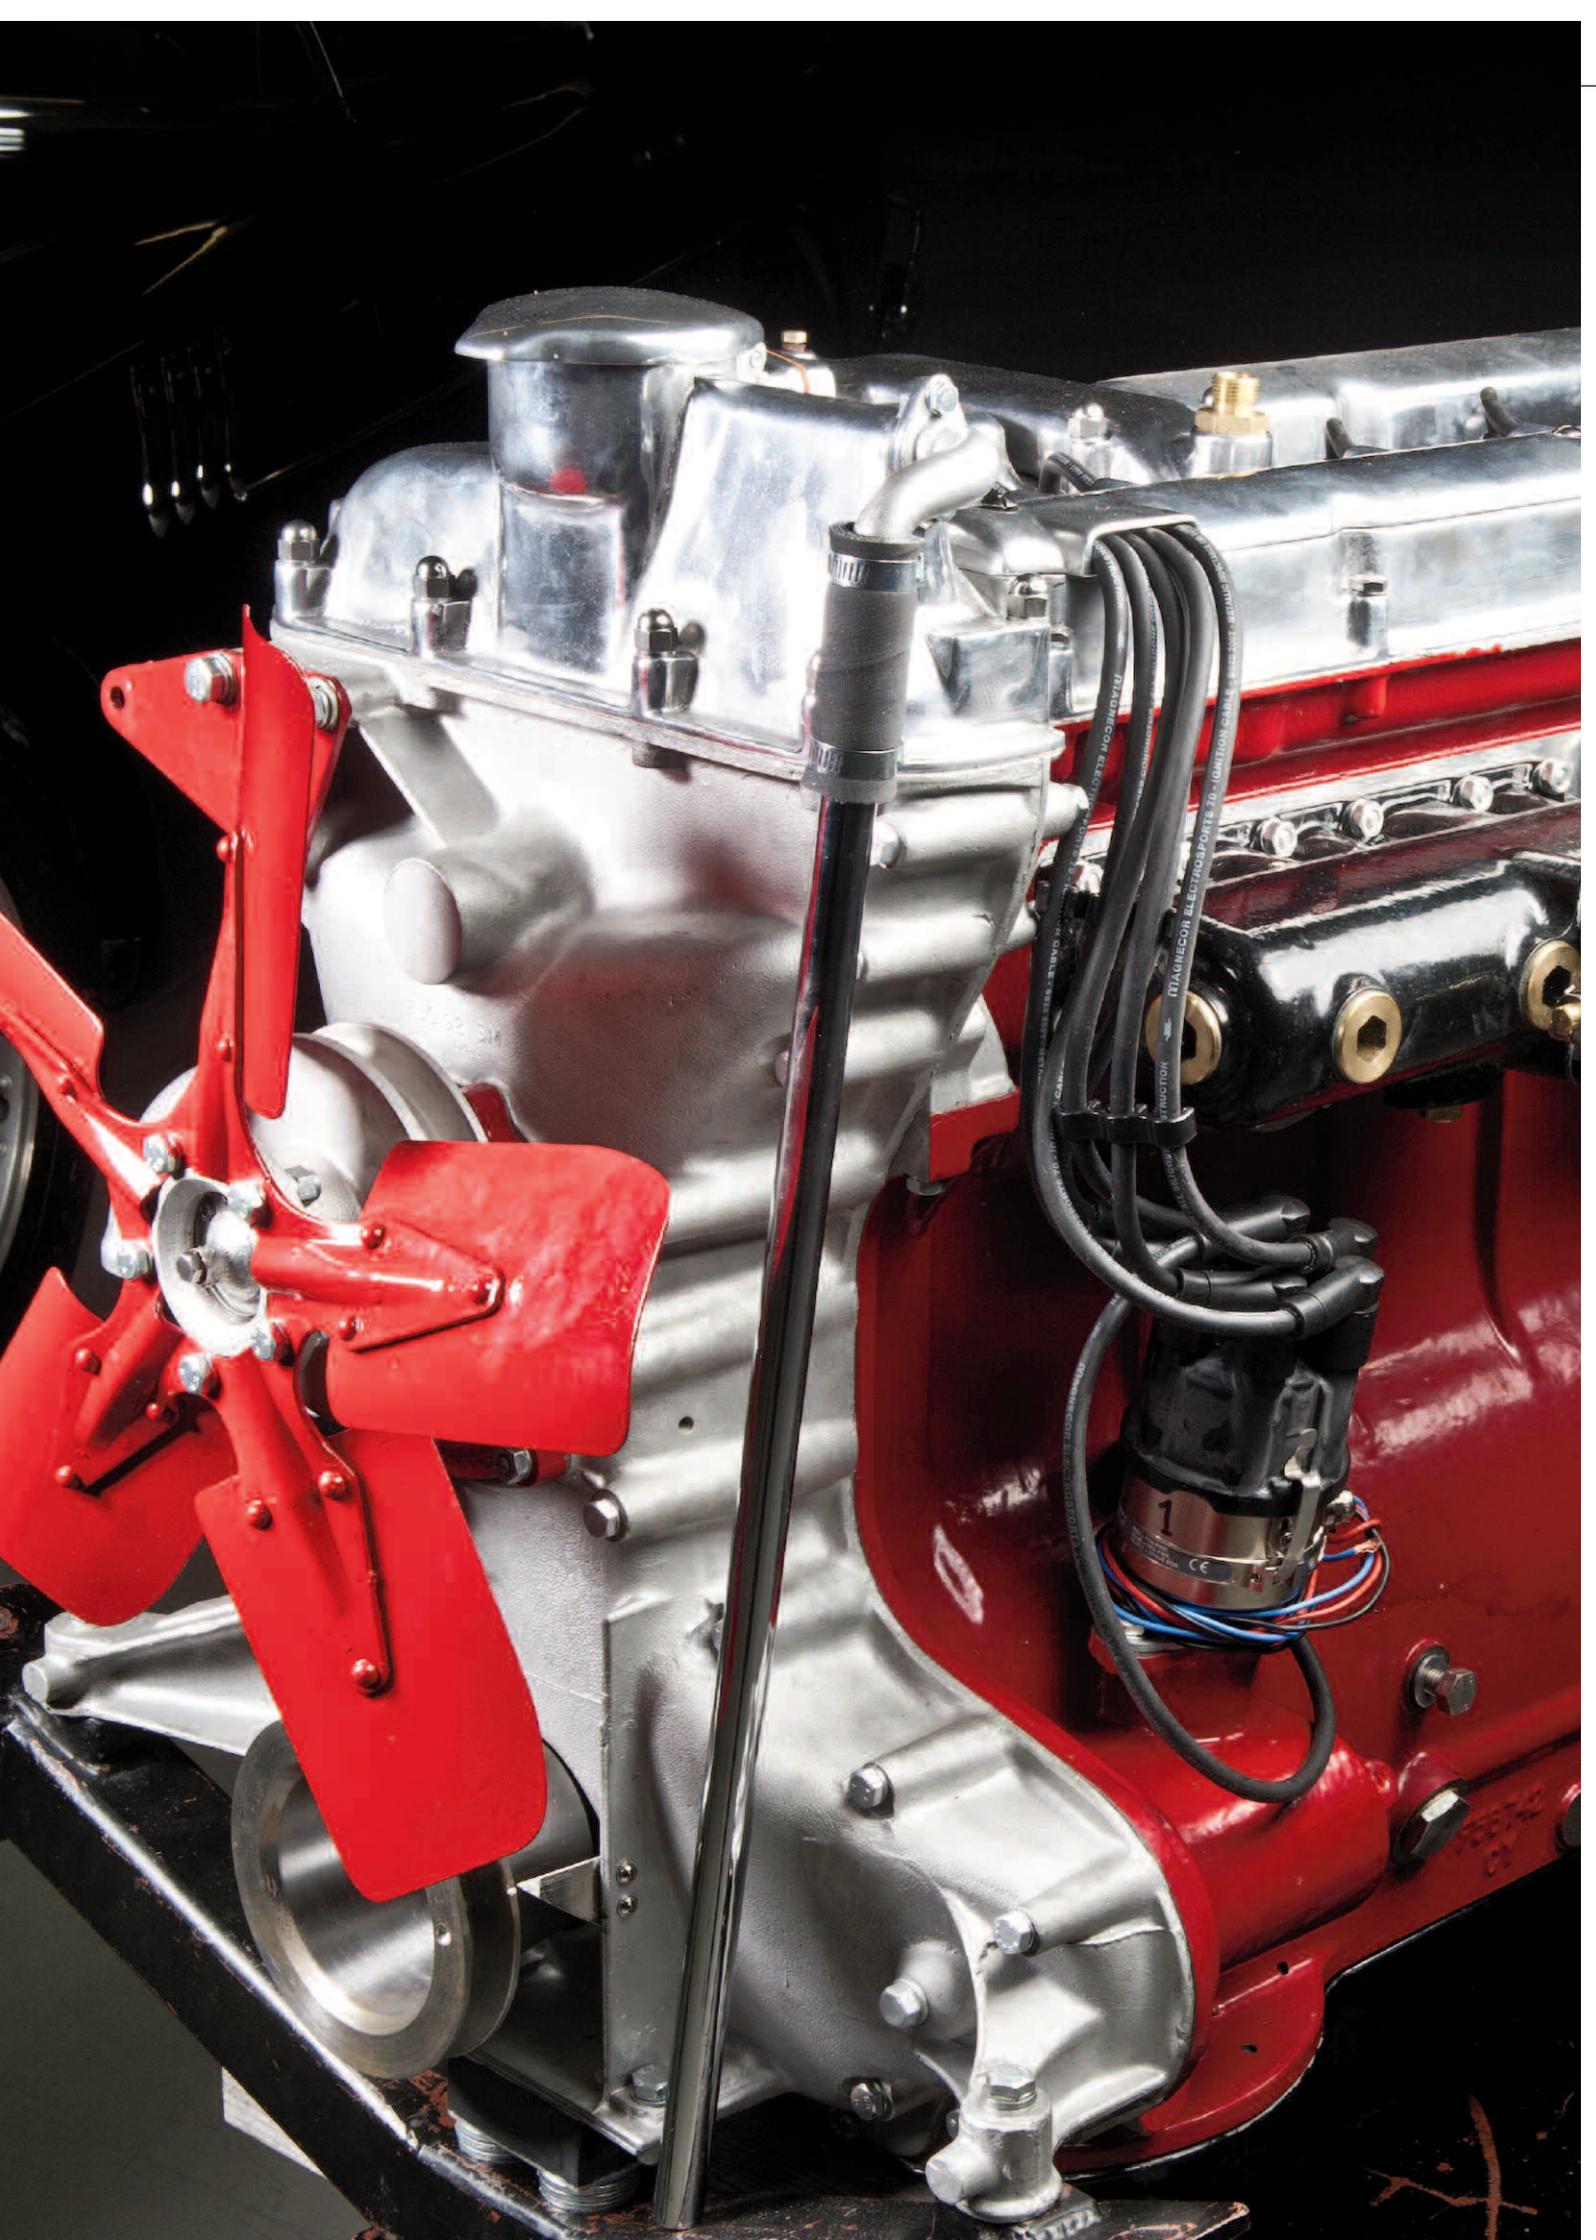
The cylinder block could be chemically cleaned and then thoroughly examined and measured, the block was found to have serious defects and cracks, the casting itself has minor differences from the following production items, the most significant of these being a lack of material around the oil gallery from the oil filter across to the main crankshaft oil supply gallery on the other side of the block.

The gallery wall was so thin and porous that it must have been leaking constantly during the life of the engine with a consequent loss of oil pressure. As a result a new block was sourced.

The design of the DB2 engine is unusual in that it features a barrel form of crankcase. With this design, three of the main bearings are mounted in split circular aluminium housings (known colloquially as cheeses). The idea is that as the engine warms up to running temperature, the aluminium 'cheeses' expand more than the cast iron cylinder block, creating a rigid crankcase. In practice, this concept does not fully deliver its promise, resulting in wear occurring, not only on the outside of the 'cheeses' but also in the locations in the block, resulting in a less than rigid assembly, the new block eliminates this problem.

The cylinder block, head and sump faces only need light machining to check they are parallel to the crankshaft centre line. The oil galleries were increased in diameter to suit the updated oil pump to be fitted. The new cylinder liners were fitted with new copper sealing rings and modern sealant after having been adjusted to give the correct protrusion above the head face, a clamping plate was fitted and the block was pressure tested to 40 PSI, the liners were then bored and honed in situ to suit the new pistons. The block was thoroughly cleaned and painted ready for final assembly of the engine.

The new cylinder block was mounted on a special engine stand. A new front main bearing bush was carefully fitted into the block and then checked for size and position. The new solid main bearing housings (cheeses) which had been machined to be a very close fit in the cylinder block locations were fitted complete with new main bearing shells on to the new forged crankshaft. The crank and bearings were now fitted into the block and the end float checked and set. The new pistons were fitted to the forged conrods and then the assemblies were fitted into the cylinder bores and onto the crank. The new uprated oil pump, oil strainer, windage plate and sump were all fitted with all internal fasteners lock-wired in position.

The new cylinder head complete with cams and new head gasket was now fitted and torqued down. The timing sprockets, tensioners, rubbing strip, new timing chains and front timing cover complete with new oil seals were then fitted and again all internal fasteners were lock-wired in position.

The valve timing was now carefully set to the camshaft manufacturer's settings and the new electronic distributor was fitted and statically timed up. All the top timing and cam covers were now fitted and the new plug leads fixed into position. The modified flywheel housing, with modern lipseal to fit onto the new modified crankshaft was then fitted and this will cure the normal 'Aston' oil leak. The fly-wheel with new ring gear and new DB5 diaphragm type clutch was now fitted and the engine is now ready to be installed on the dynamometer.

The engine was installed onto the dyno and run on a light load to achieve normal running temperature and then switched off. When the engine had completely cooled down the cylinder head bolts were re-torqued. The engine was now run for 5 hours using a gradual set procedure of building up RPM and load, during this time, the engine is constantly monitored for temperature, oil pressure etc.

The ignition timing and carburettors were checked and adjusted to the optimum settings. No oil or water leaks were found on the engine. This engine, once run in, was then put through a 500 RPM stepped power run up to 5500 RPM and the power and torque figures recorded, the figure showed the engine to be performing well with high torque readings throughout the rev range which makes it a very driveable engine when fitted in the car.

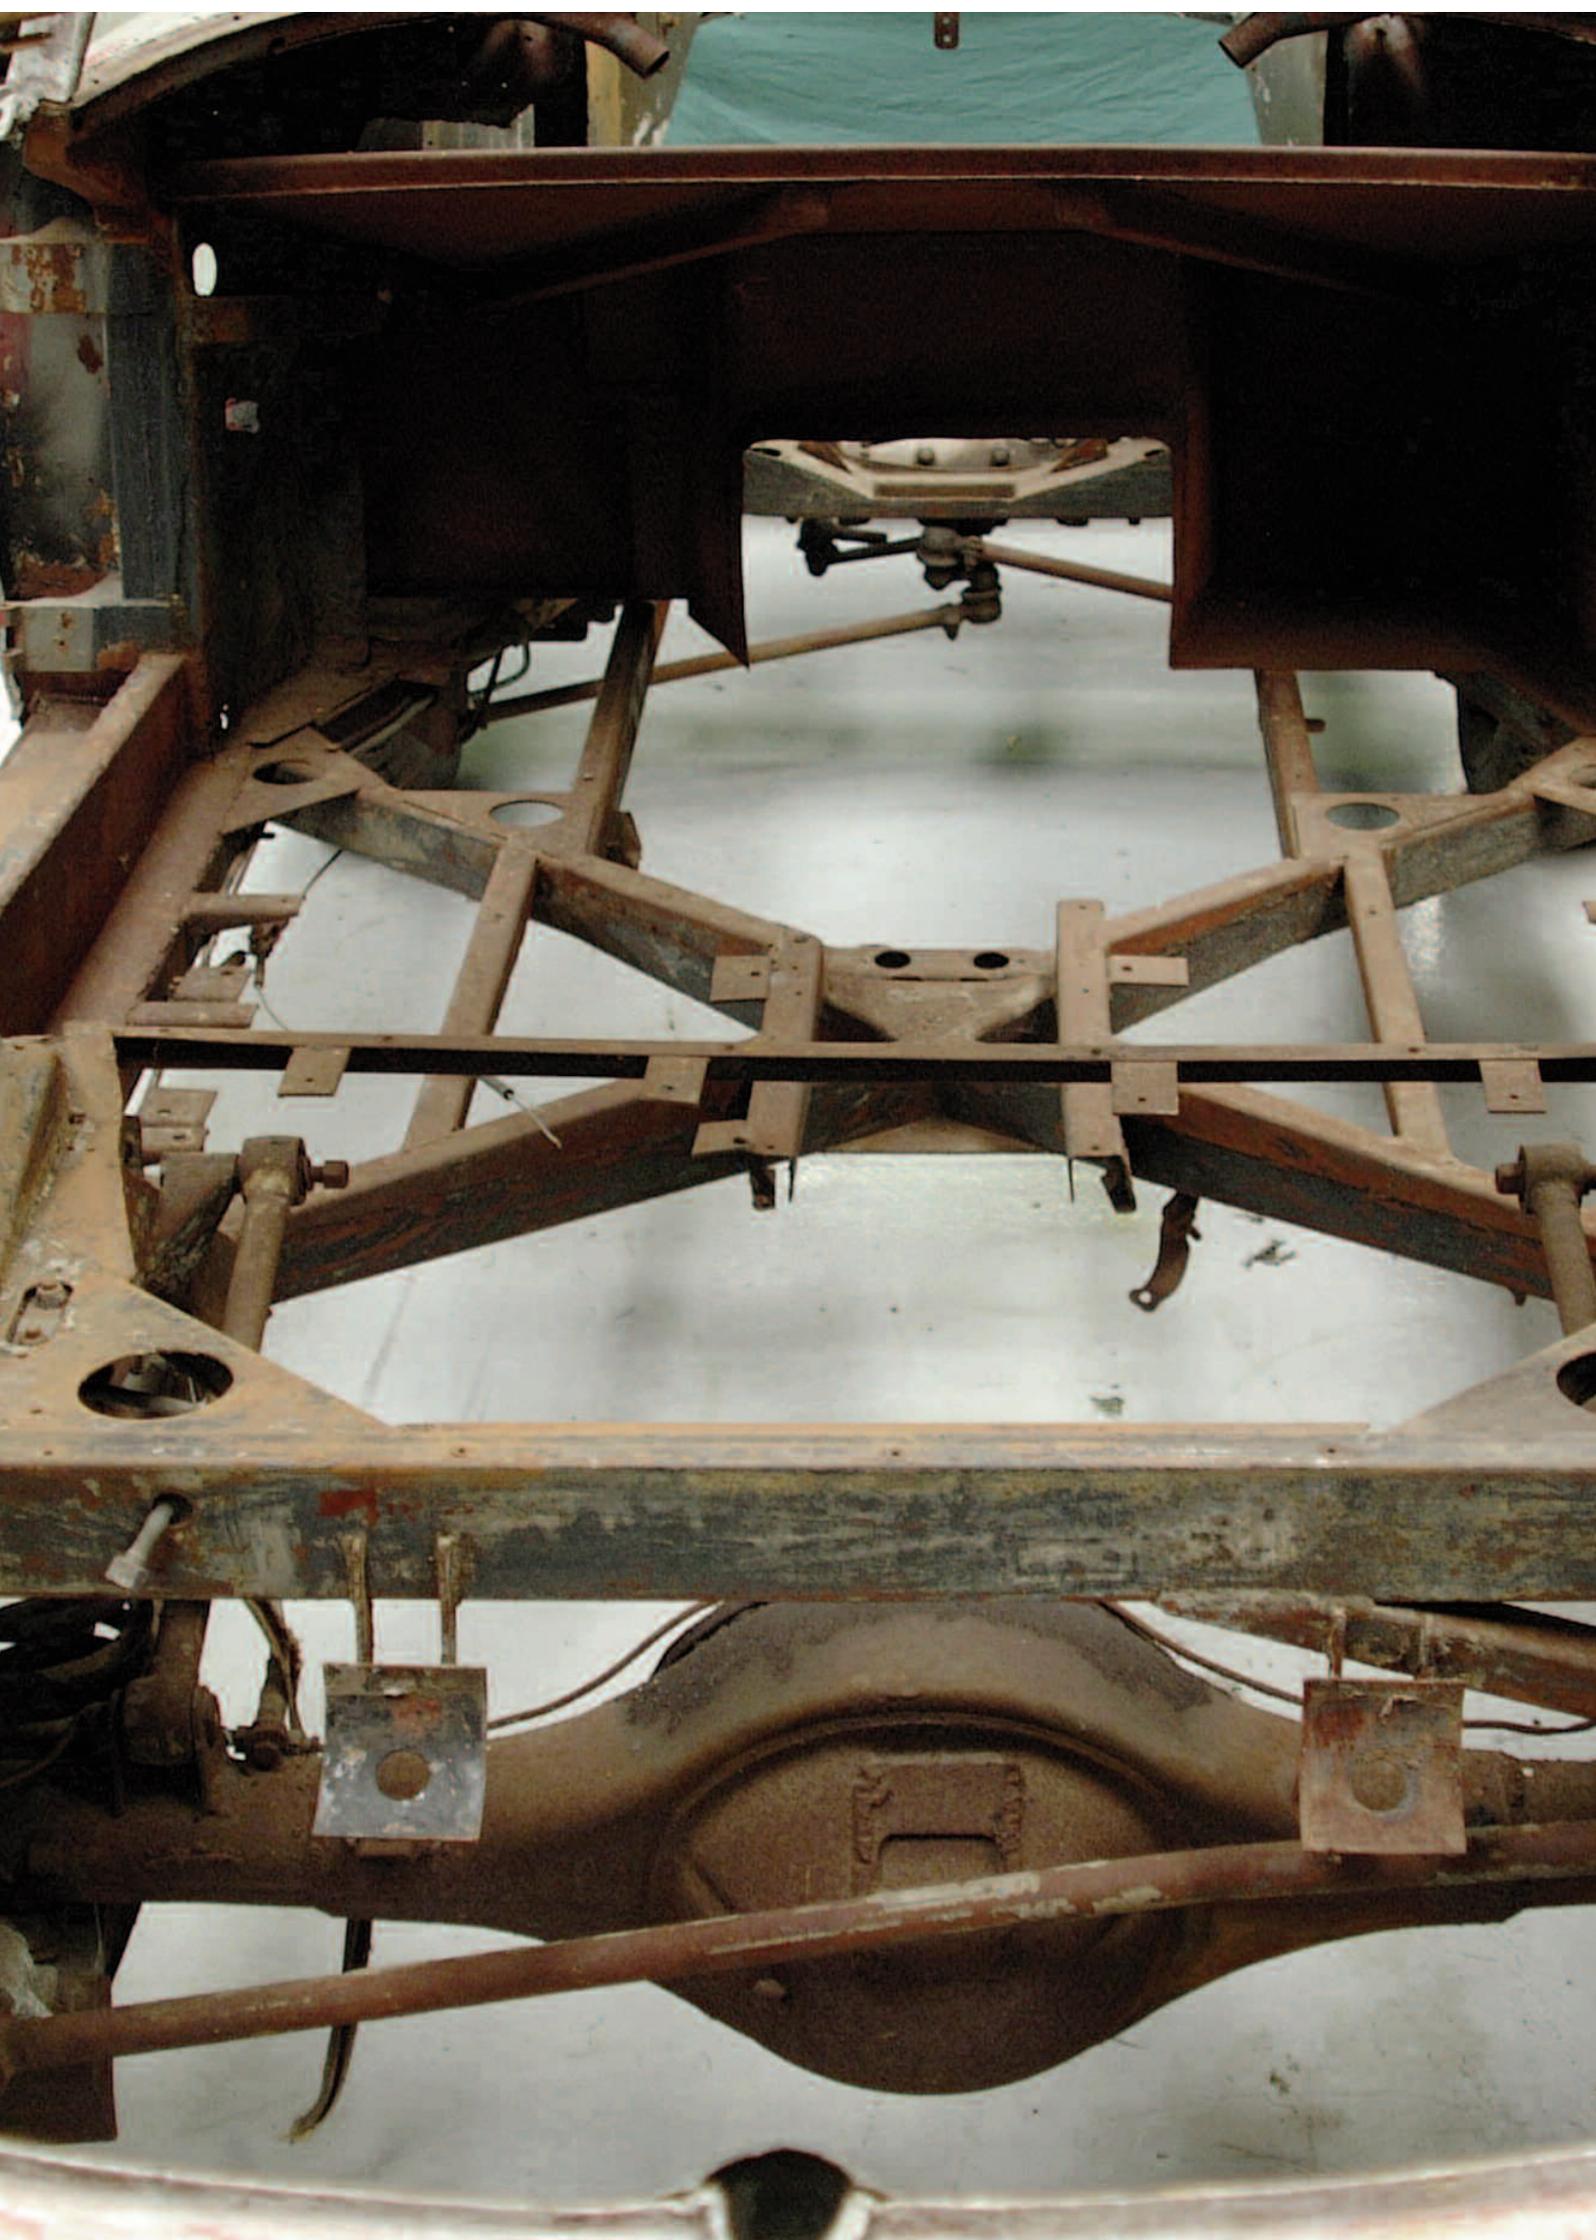
In the case of this chassis assembly, there was relatively little in terms of repairs necessary on the tubular chassis, other than bead blast and painting.

Over time however, fillet sections, floor panels, rear wheel arches, timber fillets, B posts and sections of the front bulkhead were all in need of attention and in many cases, replacement.

In the case of this car, other than floor panels, sections of the front bulkhead, and new rear wheel arches which were fabricated and welded into position, there was relatively little new metal required in the chassis tubes.

The first requirement in repairing the chassis was to place it in our special jig. This has a number of essential benefits. First, it ensures that should there be any distortion and evidence of accident damage, this is identified so that the chassis can be straightened. Second, it ensures that as the chassis repair is ongoing, the chassis is rigidly and fully supported, so that as any repairs and new sections are let in, that movement and distortion of the chassis is avoided. Third, it provides a means of supporting the chassis at a convenient height, thereby aiding considerably ease of repair.

new well-seasoned ash timber sections being fashioned, planed and shaped to size. In keeping with restoring the car to the highest standards, the complete and repaired chassis was primed, undercoated and powder coated in satin finish black.

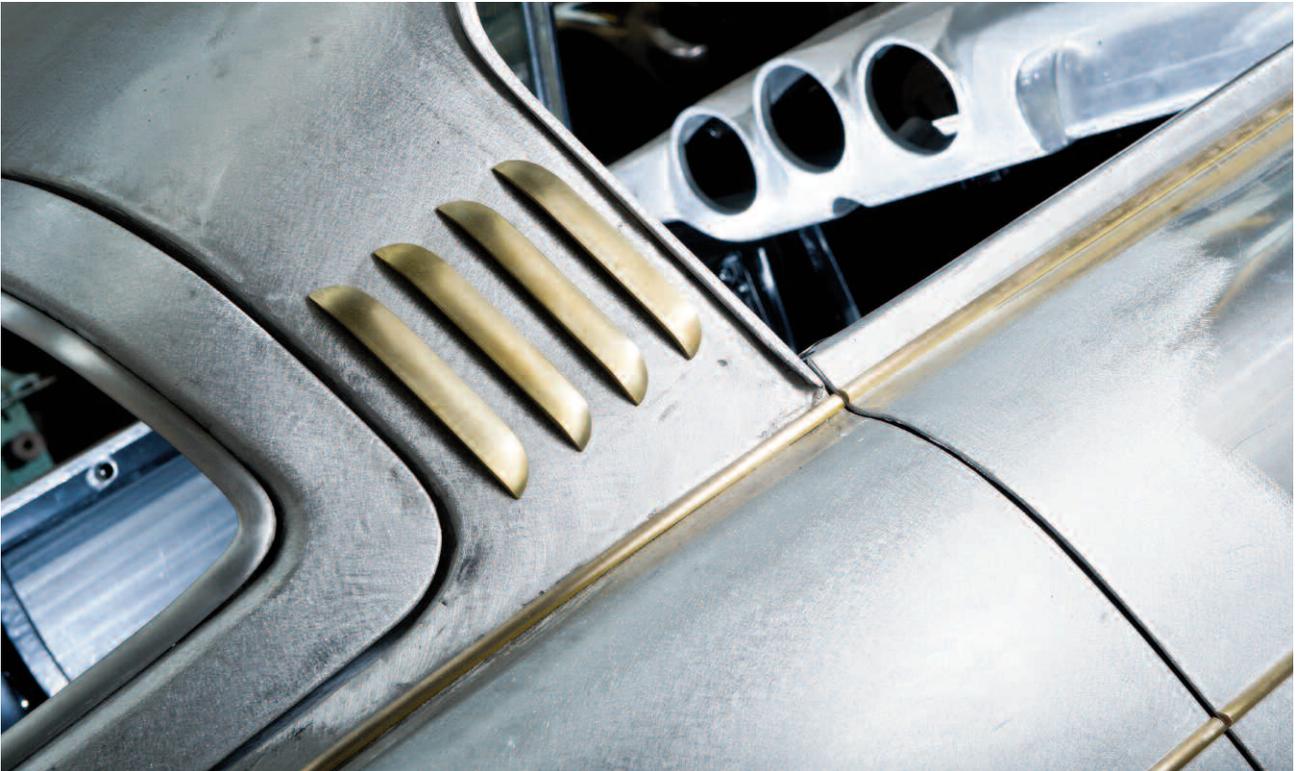
Body Reconstruction

In keeping with the Aston Workshop restoration policy, it was usual to refurbish the body shell front and rear and to fit this to the restored chassis. In keeping with this policy, LML/802 was duly dispatched to Shapecraft, for the refurbished shell to be fitted and shaped, modifying as required to ensure perfect alignment.

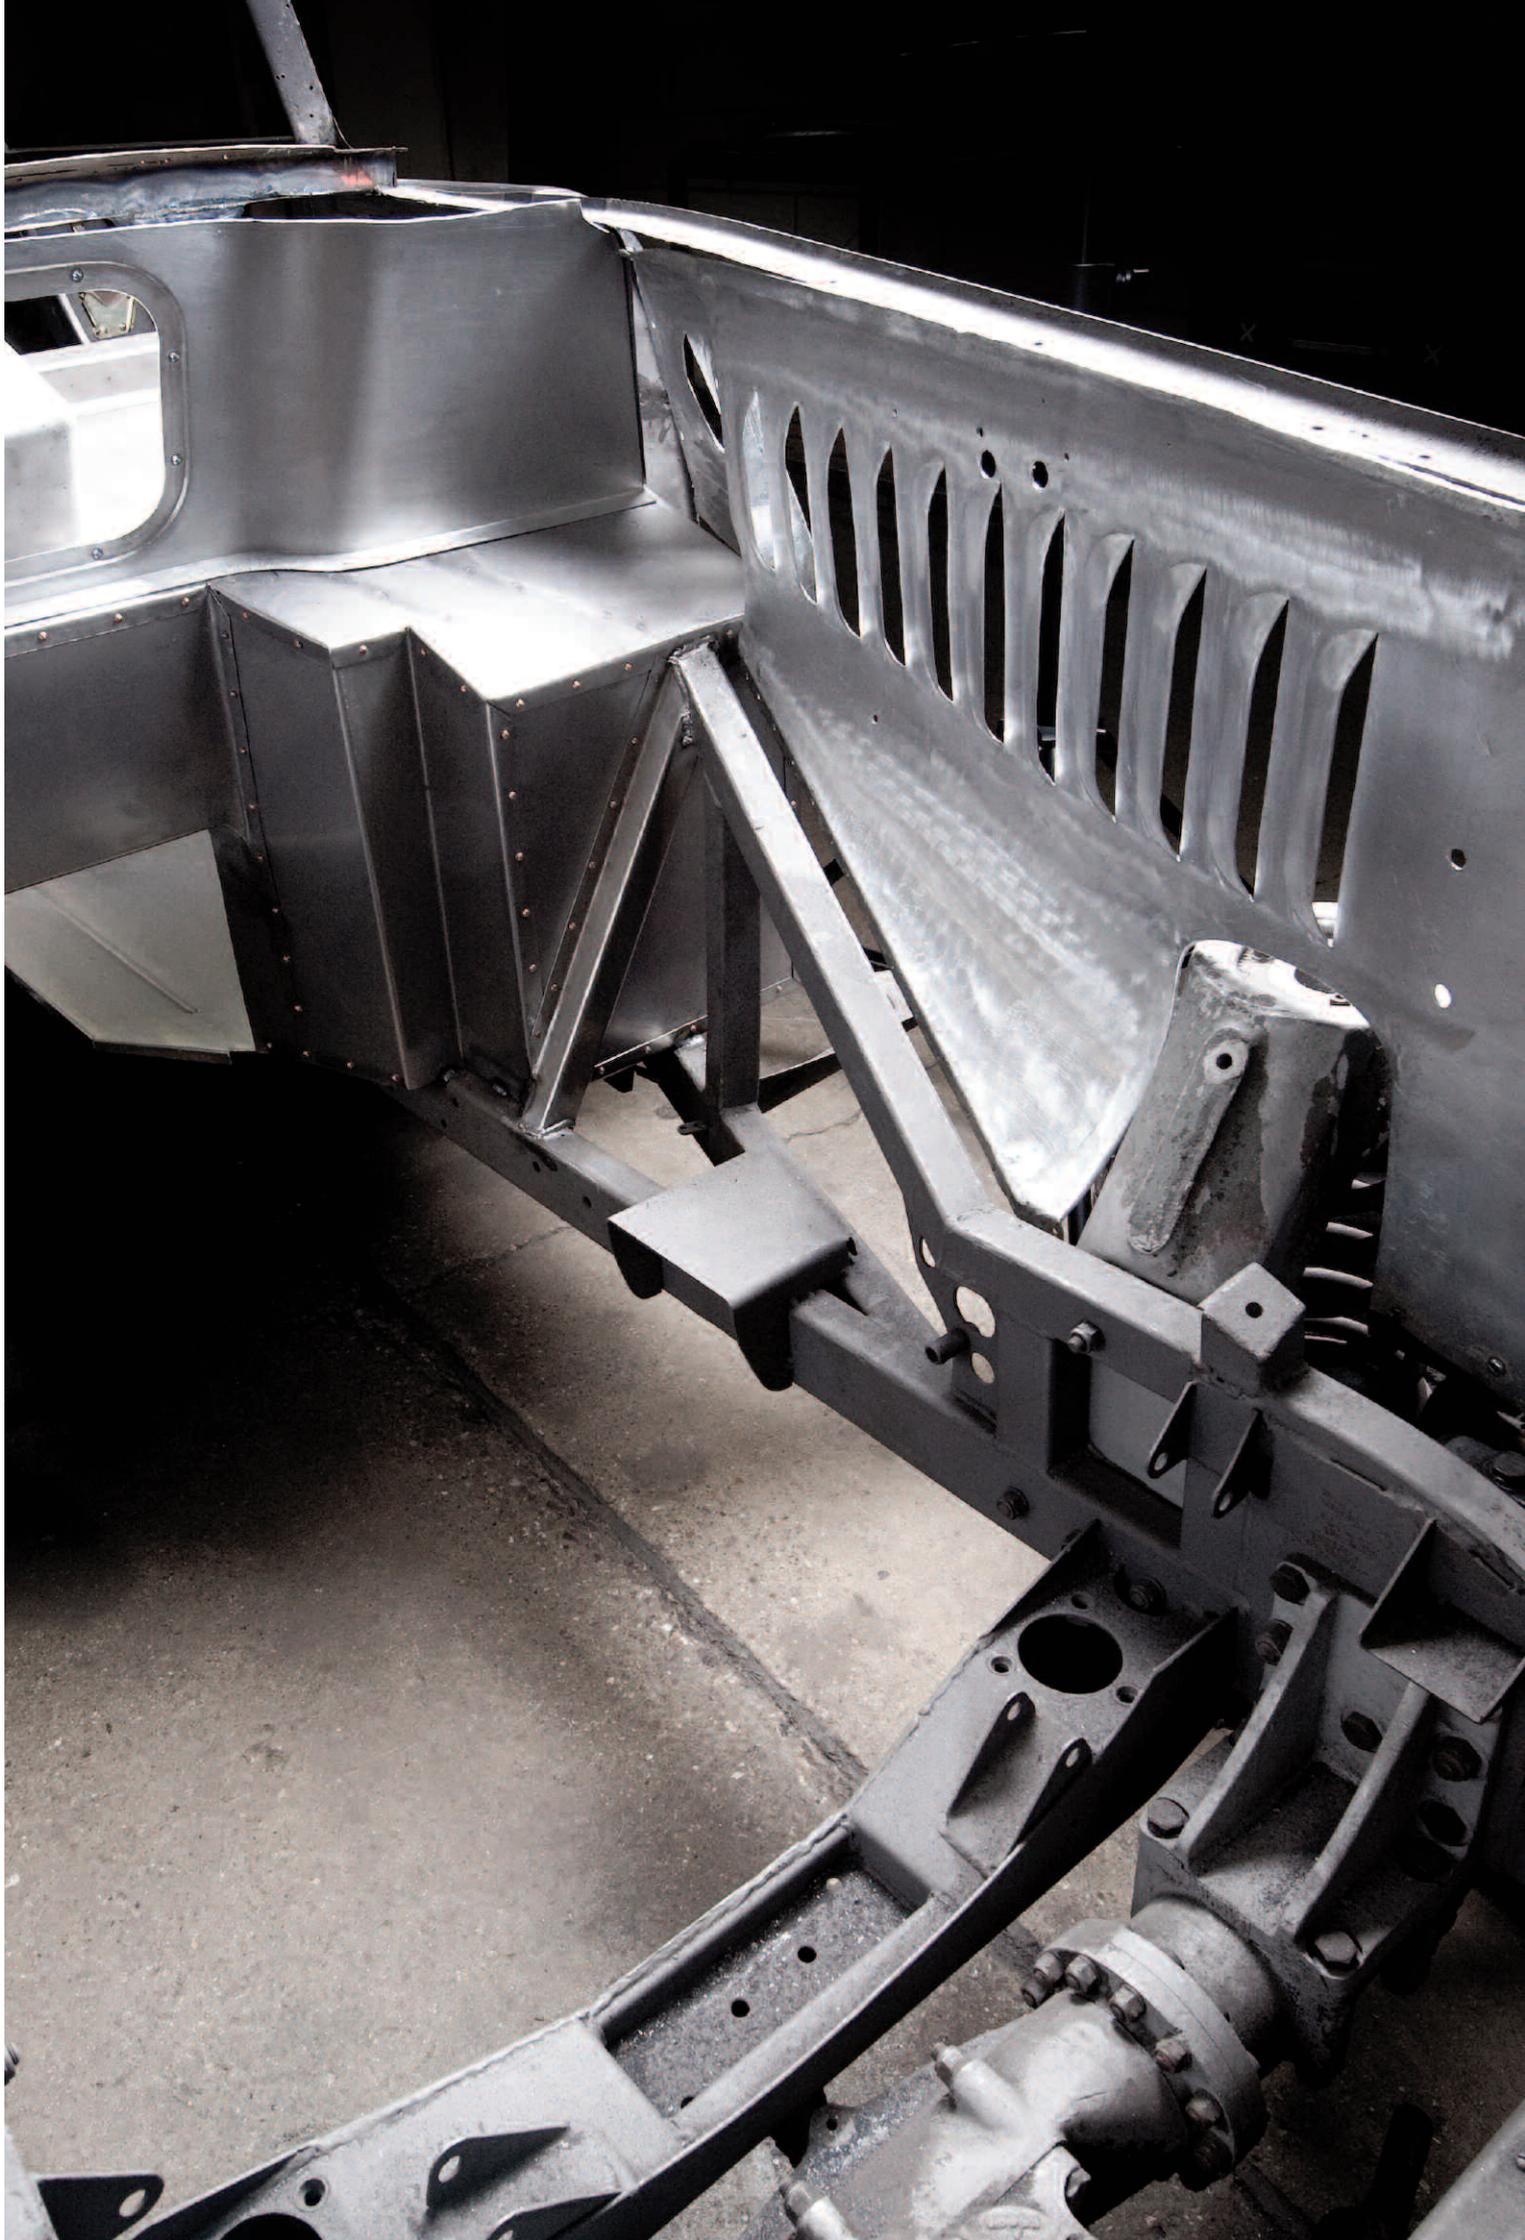
Once the shell had been fitted, there was then the highly skilled task of finally shaping the outer panels to ensure a perfectly smooth surface for priming and painting.

The first stage of painting was to etch prime the body shell. The object of etch priming was to provide an impermeable barrier to any moisture and to provide the best possible adhesion of subsequent primer, filler (if any required), paint and lacquers. Any final shaping of aluminium panels was then undertaken to ensure the best possible standard of finish and to ensure the barest minimum of filler was used in the next stage of preparing the panel surfaces for final painting.

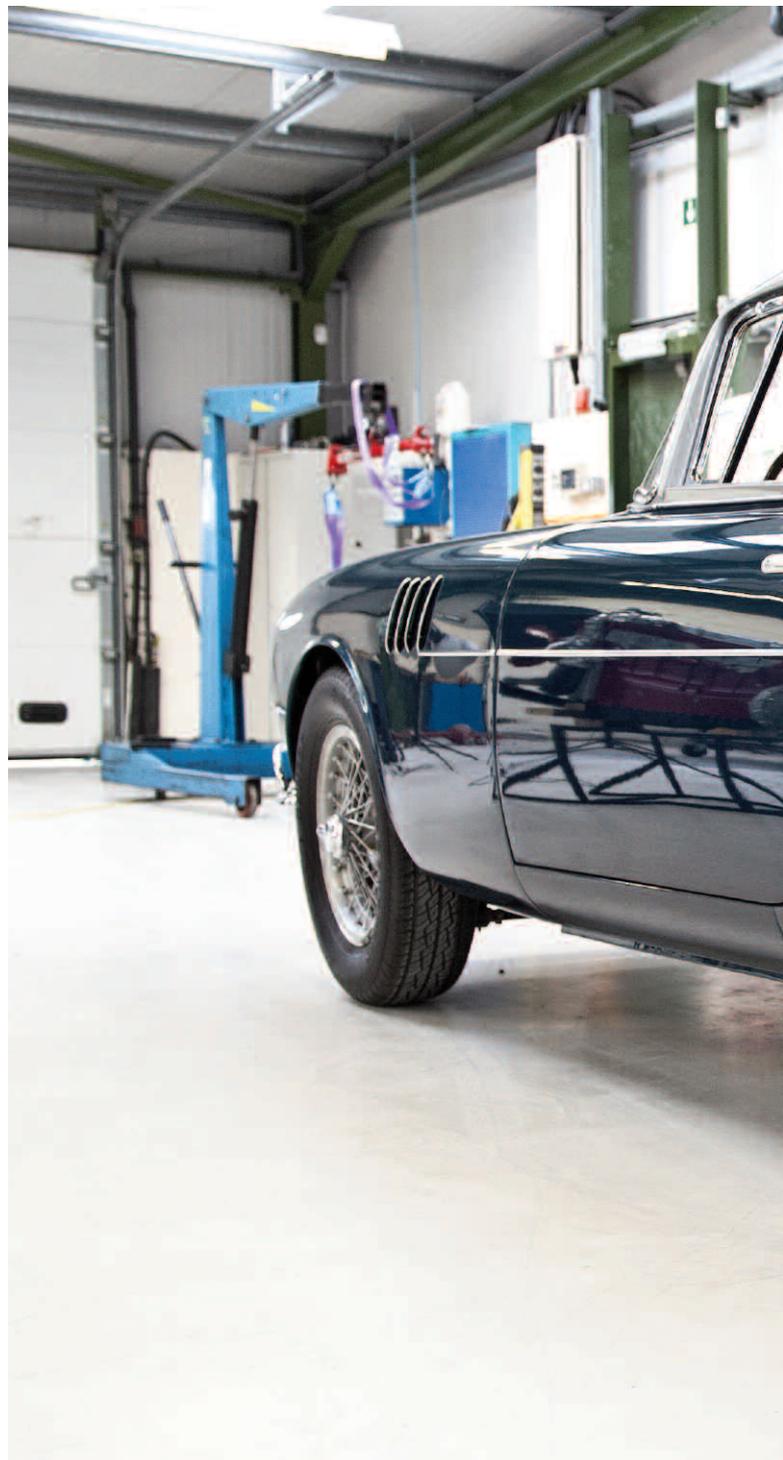
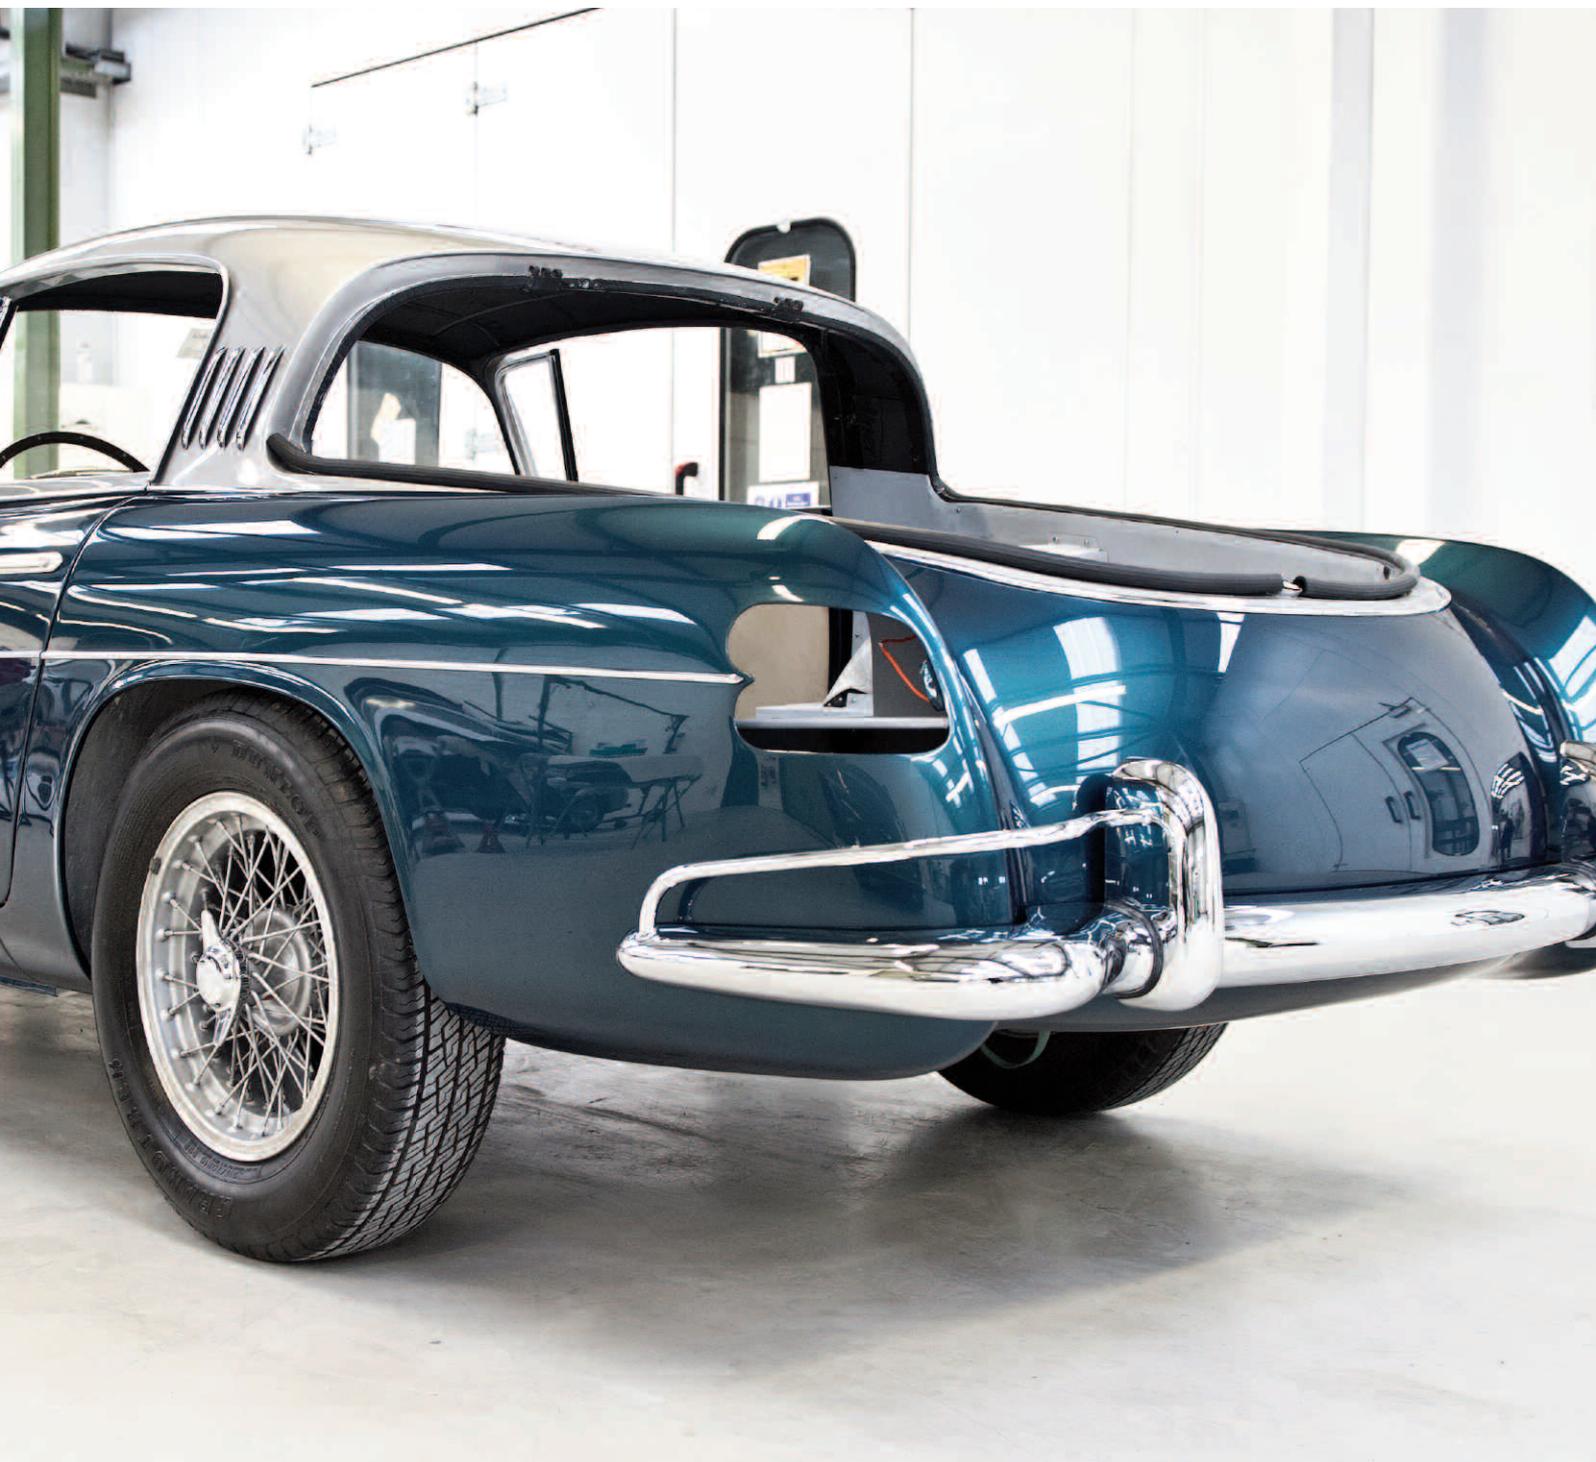
Priming and Filling

The body shell was then given two coats of high build primer, followed by a light guide coat and this was allowed to fully harden. A long process of rubbing down followed to ensure that perfectly smooth and flat surface. A small skim of filler was used where necessary to compensate for any minor deviation of the panel from the perfect shape. Only when an even guide coat finish was achieved and the surface perfectly smooth was the body shell passed as fit to move to the final painting stage. The same process was used for the doors, bonnet, boot lid and petrol filler flaps. The final stage was to refit the doors and other opening panels to do any final adjustment in the gapping, ensure that adequate clearance was provided and a perfect match of the front and rear body panels with the doors, boot lid and bonnet was achieved.

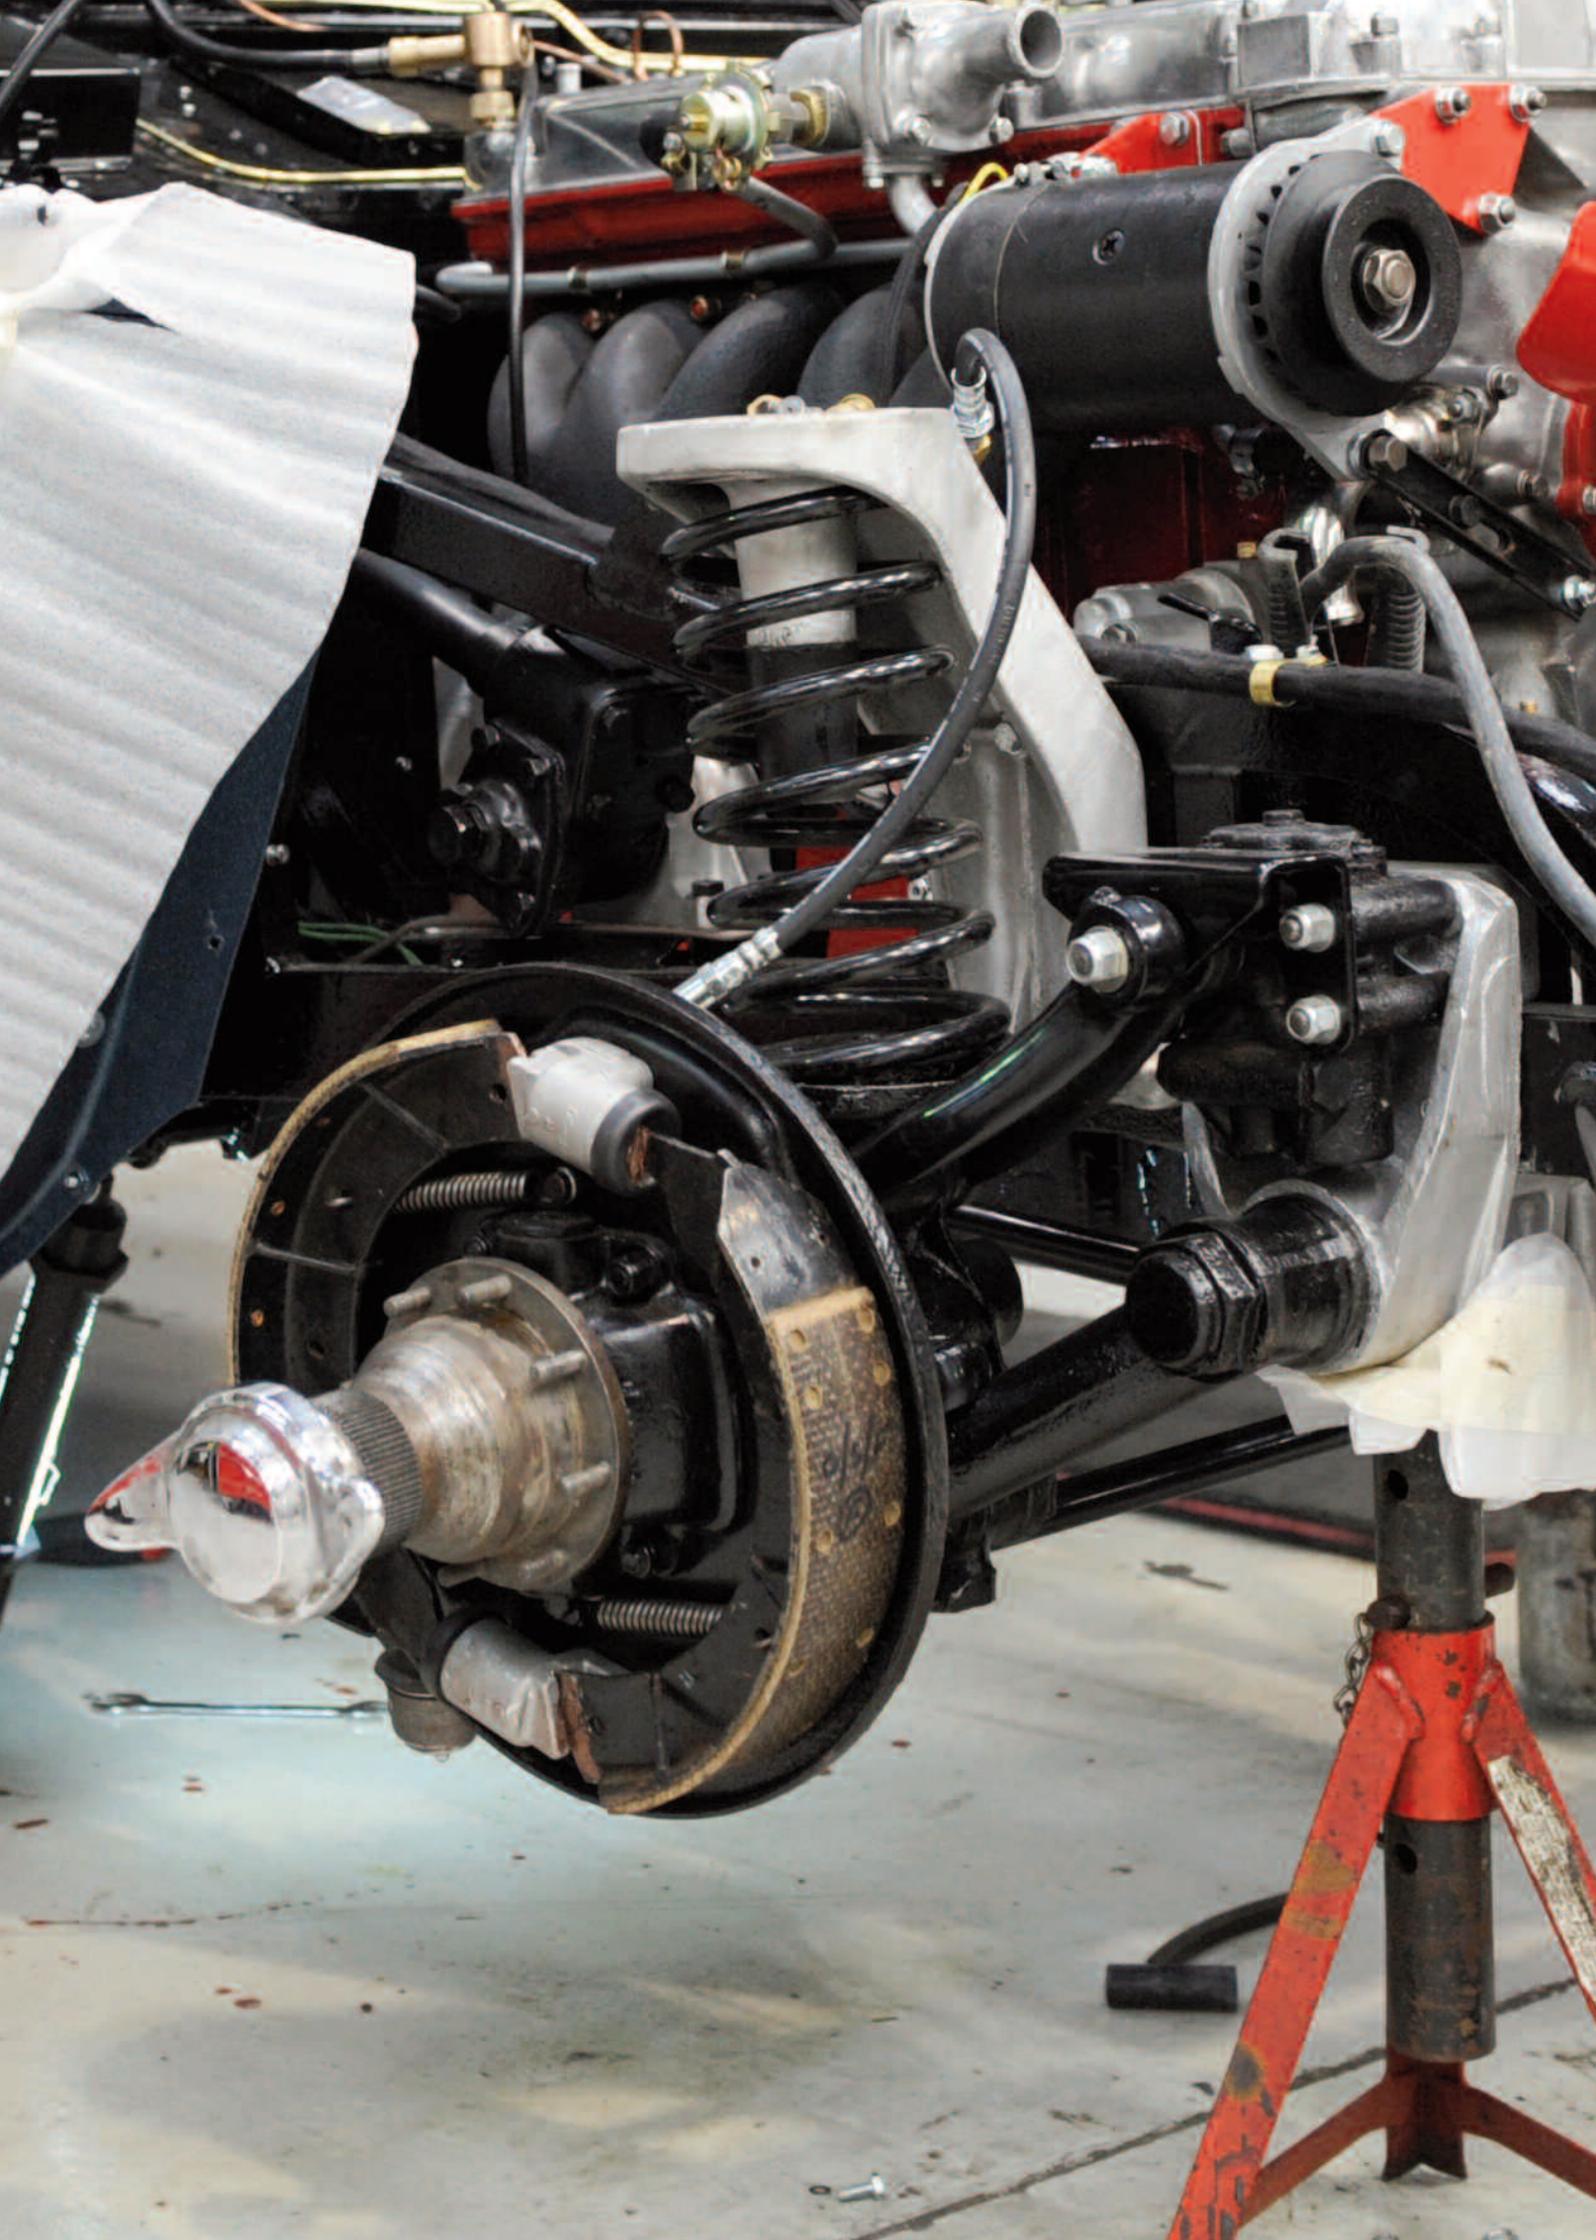
Another unusual feature of the DB2 is the use of a trailing arm front suspension. The design generally works well but the anti-roll bar and lower trailing arm bearing is housed within an aluminium casing and doubles as an oil bath for the needle roller bearings and over time the oil seal deteriorates and wear increases. The overhaul therefore involved fitting new roller bearings and seals. The steering is also of an unusual design, featuring divided track rods, the inboard ends of which connect to a crank that is horizontally pivoted. The crank pin of this steering crank also wears and as part of the overhaul was fitted with new roller bearings. New track rod and drag link ends were then assembled on each of the track and drag rods and these put to one side awaiting assembly.

The restoration specification featured electric power assisted steering. This then necessitated dispatching the original steering box and column for modification and overhaul. The existing drum brakes were retained and refurbished as required.
