## Restoration Log

### Aston Martin DB6 MKI Vantage

Aston Workshop, Red Row, Beamish, County Durham, DH9 0RW, England.

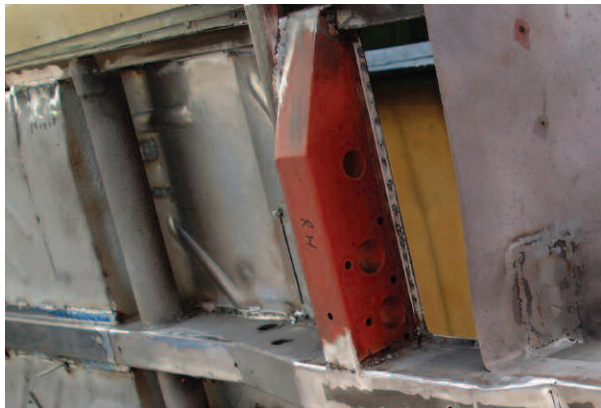
Once this had been done, the outer aluminium sills were removed, and the chassis was then cleaned back to remove all of the residual oil, grease and general muck that had accumulated, of which there was a huge amount. This was a filthy job, but vital if the grit blast of the structure that followed was to be fully effective in removing all of the surface rust. It was only when the grit blast was completed that it became possible to acquire an indicative assessment of the chassis structure that lay underneath. Early assessments of the structure indicated that in this

case, the outer forlorn state of the car was perhaps also an accurate indicator of its inner state, which was poor.

Not only were the sills showing an advanced state of decay but also the front outriggers, the rear chassis legs and a boot floor that showed more resemblance to lace than something solid. The rear suspension anchorages were equally unsound.

At the front, the base of the front foot wells, the front engine bulkhead and cross member was also heavily rust damaged, as were the under-bonnet side panels.
