Restoration Log

Aston Martin DB6 MKI

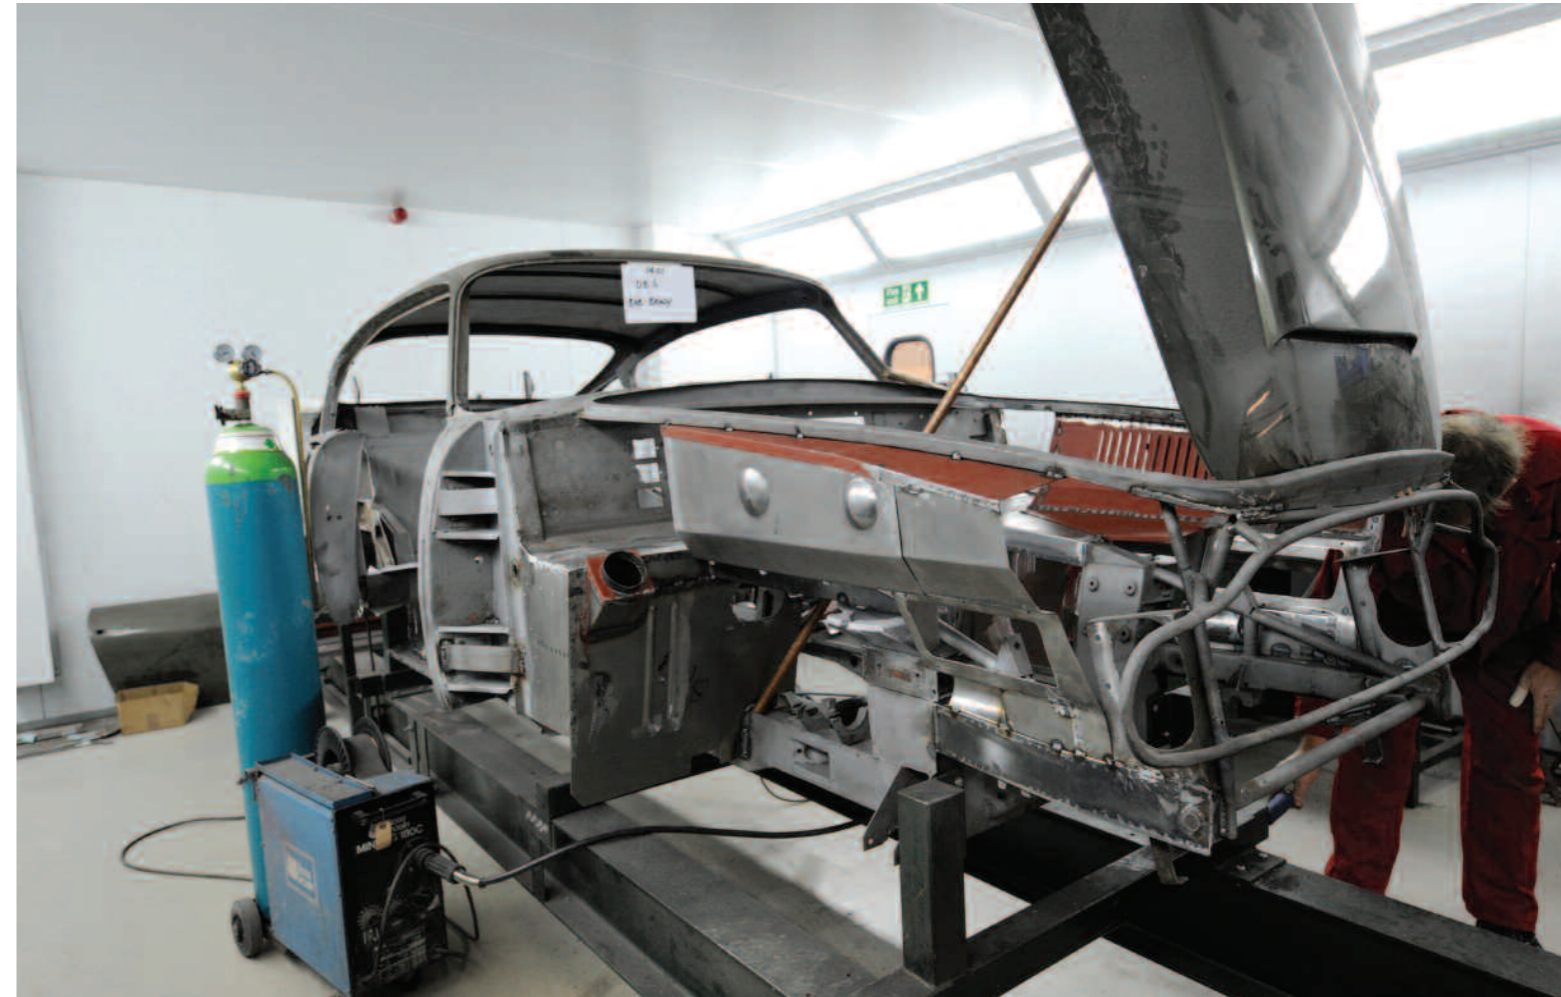
case, the outer forlorn state of the car was perhaps also an accurate indicator of its inner state, which was poor.

Not only were the sills showing an advanced state of decay but also the front outriggers, the rear chassis legs and a boot floor that showed more resemblance to lace than something solid. The rear suspension anchorages were equally unsound.

At the front, the base of the front foot wells, the front engine bulkhead and cross member was also heavily rust damaged, as were the under-bonnet side panels.

The chassis reconstruction involved repairs to almost every section and panel below the top of the A and B posts. Important structures replaced in toto involved the sills, offside and near side front outriggers, large section of the chassis leading back from the front cross member and which supports the front suspension and new jacking points. At the rear, virtually the complete rear suspension supporting structure required to be replaced, as well as the support legs leading backwards to support the boot floor. Within the bonnet area, not only did the panels either side of the bonnet require replacement, but also all of the forward structure from the front suspension uprights back to the engine bulkhead. Sections of the front bulkhead showed significant deterioration and rust damage and areas had to be cut out and replaced. All of the floor sections had to be replaced and welded into place, as also the rear seat pan, which had been holed.
