# Aston Workshop

## Restoration Log

Aston Martin DB2 Chassis no. LML 50/186

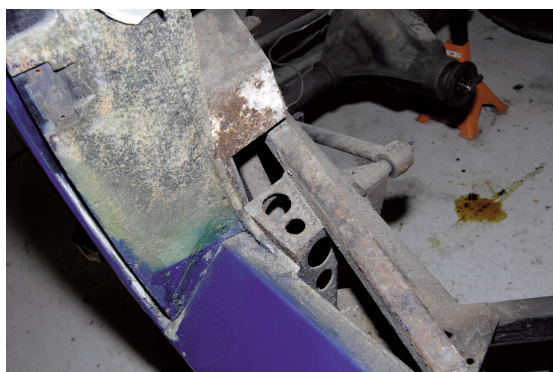
Right from the outset, it was known that there was only one way that this car could be rescued and restored to her former glory and that would be to assume everything would need to be stripped, assessed, replaced or overhauled. As with any restoration, the first task is to strip her of everything that can be removed, starting with the doors, bonnet, boot, engine, gearbox, front and rear suspension and glass.

The next stage was to strip out the interior fittings, trim and then the dashboard, followed by the wiring looms and under bonnet fittings, all the while carefully cataloguing what had been removed, labelling everything and storing. The engine, gearbox and final drive were then stored until required, as were all of the suspension, steering column and box, brakes, hubs and related items. Window guides and fittings followed, as with the door handles, catches and aluminium trim.
