# Aston Workshop

## RESTORATION LOG DB6/2914/R

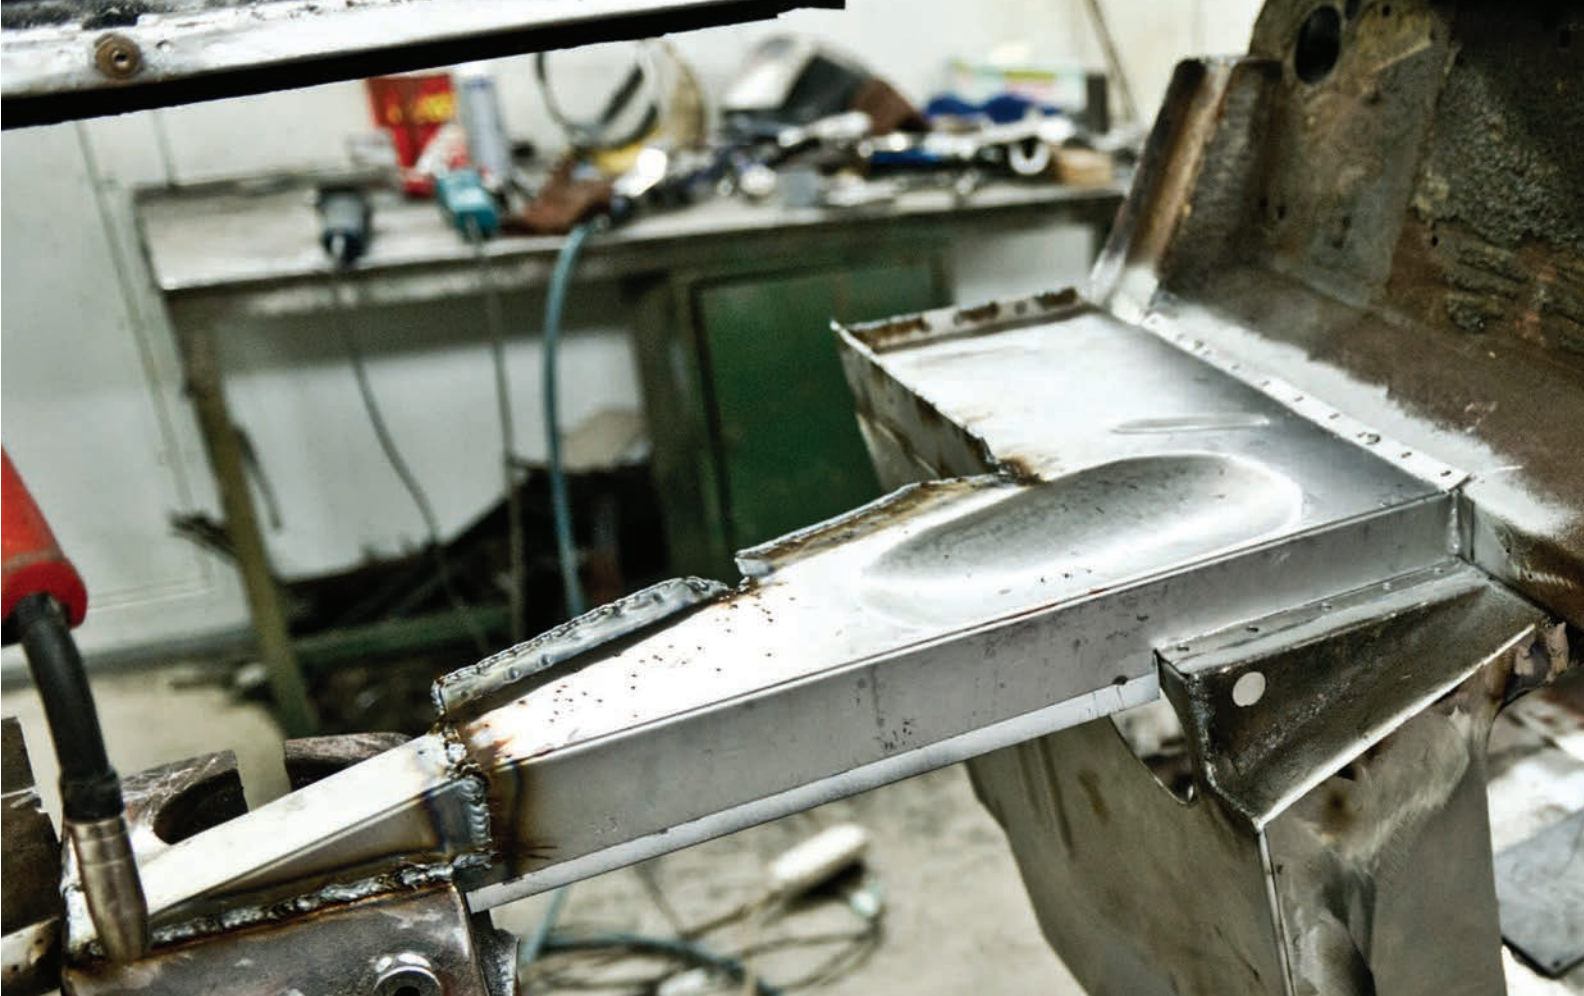
case, the outer forlorn state of the car was perhaps also an accurate indicator of its inner state, which was poor.

Not only were the sills showing an advanced state of decay but also the front outriggers, the rear chassis legs and a boot floor that showed more resemblance to lace than something solid. The rear suspension anchorages were equally unsound.

At the front, the base of the front foot wells, the front engine bulkhead and cross member was also heavily rust damaged, as were the under-bonnet side panels.
