Restoration Log

Aston Martin DB5 /2263/R Chassis no.
Engine no.400/2277

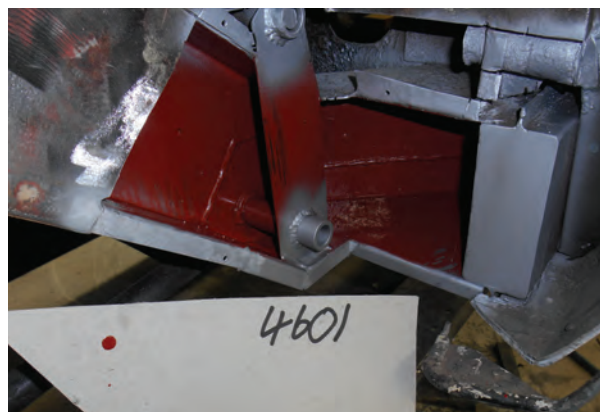
Once this had been done, the outer aluminium sills were removed, and the chassis was then cleaned back to remove all of the residual oil, grease and general muck that had accumulated, of which there was a huge amount. This was a filthy job, but vital if the grit blast of the structure that followed was to be fully effective in removing all of the surface rust. It was only when the grit blast was completed that it became possible to acquire an indicative assessment of the chassis structure that lay underneath. Early assessments of the structure indicated that in this

case, the outer condition was perhaps not an accurate indicator of its inner state, which boasted a previous refurbishment but was in fact in poor condition.

Not only were the sills showing an advanced state of decay but also the front outriggers, the rear chassis legs and a boot floor that showed more resemblance to lace than something solid. The rear suspension anchorages were equally unsound.

At the front, the base of the front door posts, the front engine bulkhead and cross member was also heavily rust damaged, as were the under-bonnet side panels.

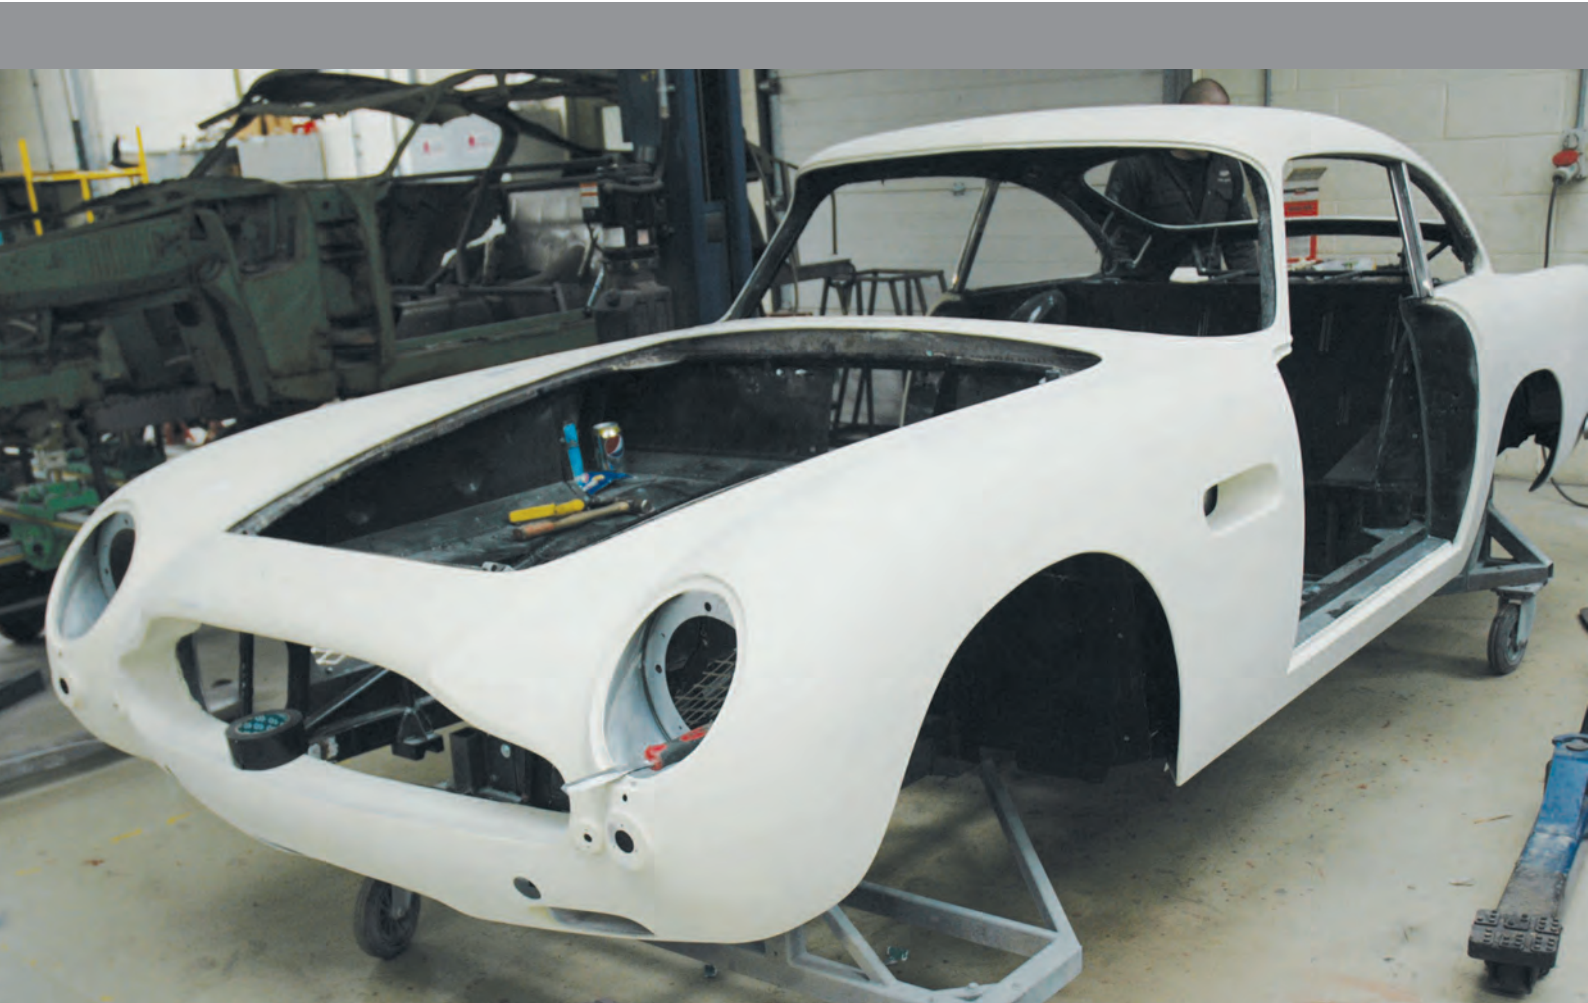
The usual way aluminium corrodes is through a form of corrosion known as crevice corrosion and while outwardly, a piece of aluminium skin may look in reasonable condition, it is common to find that the corrosion damage has created a pin hole. There is no long term alternative but to cut out and replace the affected panel. Restored cars only exceptionally, when stripped, are undamaged

around front and rear wheel arches, around the outside of the boot floor and in the vicinity of the bonnet aperture and sills. In the case of this car, new metal was required in all of the usual places. Door skins were replaced as a matter of course along with the reconstruction of the doors, the two elements being done together to ensure that dimensional alignment was retained.
