# Aston Workshop

## Restoration Log

Aston Martin  
DB5/1537/R

Engine no.400/1557

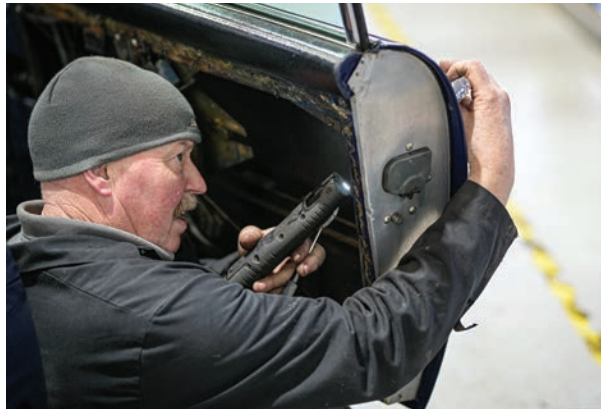
## The Strip

The objective of the strip stage is to remove all components, trim, filth and paint prior to the separation of the outer aluminium body shell from the steel chassis. The first stage for the strip of this restoration was to remove all interior trim and glass, which was then labelled and carefully stored. Next followed the bumpers, all bright trim and light fittings. The transmission tunnel was removed followed by the removal of the radiators, the engine and the transmission.

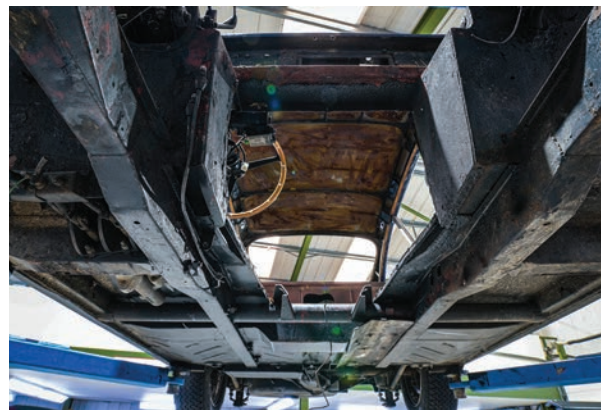
Early assessments of the structure indicated that in this case the outer condition of the Aston was perhaps an inaccurate indicator of its inner state, which was very poor. Our assessments also indicated that in this case, the forlorn state of the chassis was perhaps also an accurate indicator of its

inner state, which following internal camera inspection of the box sections was poor. Not only were the sills showing an advanced state of decay but also the front outriggers, the rear chassis legs and a boot floor that showed more resemblance to tissue than something solid. The rear suspension anchorages were equally unsound. At the front, the base of the "A" posts, front foot wells, and the front engine bulkhead were also heavily rust damaged, as were the under-bonnet side panels.

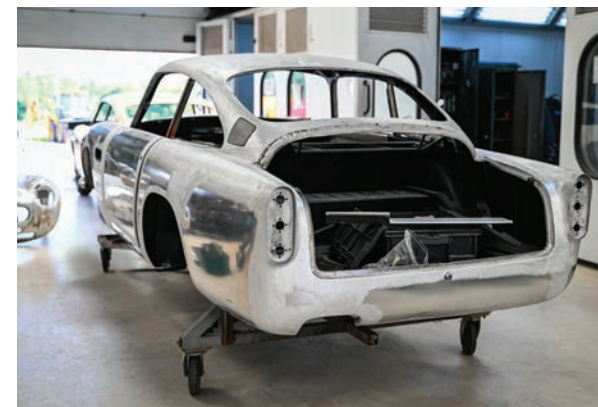
Every Aston that visits Aston Workshop for restoration will have a unique past, therefore the level of panel replacement needed is dependent on our in-depth assessment. In keeping with this approach, the restored chassis was treated to replacement front body sections while the rear panels were considered in good shape and worthy of being reused in line with our preference for originality. Panels were finely shaped as required to ensure perfect alignment with the roof section and main structural sections of the chassis (these being the sills, "A" and "B" posts, bonnet aperture, windscreen frame, rear window frame, and boot aperture). The door frames were reconstructed once the front and rear shells had been fitted and aligned, thus ensuring perfect door alignment, and then re-skinned and trimmed to align with the adjoining panels.

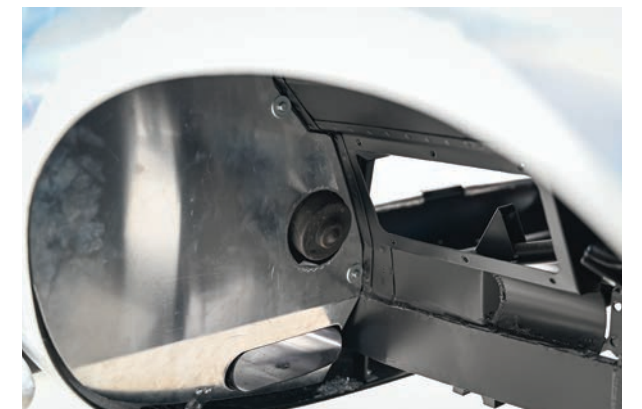
The final stage of preparing the body for painting was to carry out a final shaping and prefit of window frames, bumpers, light fittings and headlight glass cowlings. During the course of this stage the objective was to ensure a perfectly smooth shape so far as it was possible with minimum use of filler. It was also to ensure that the gapping of the doors, bonnet and boot were perfect, all of the external bright trim, light fittings, radiator grille fitted correctly, and gaps and apertures were adjusted as required. When undertaking the final door gapping, the engine and transmission were briefly refitted, together with front and rear suspension to ensure that any small flex in the chassis was accounted for in that final alignment. Another key aspect of this stage was to ensure that the aluminium surface was filed into a state that would allow the best possible adhesion of the etch primer to follow in the initial stage of painting the body shell. The doors, bonnet and boot lid were then removed for later painting.

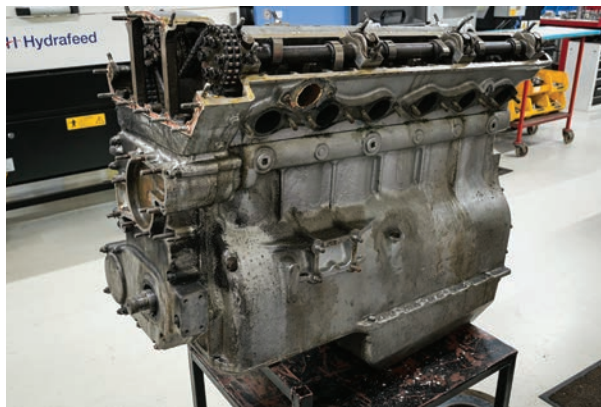
As this engine was to be totally restored, the next stage was to remove pistons and connecting rods, followed by the crankshaft, oil pump and strainer assembly and all the external fittings. The cylinder block was next inserted into an oven and heated, followed by the extraction of all cylinder liners. This revealed that the seatings for the liners, though damaged by age and corrosion, could be recovered by welding and machining, thus retaining an original matching numbers engine to live with the original rebuilt chassis.

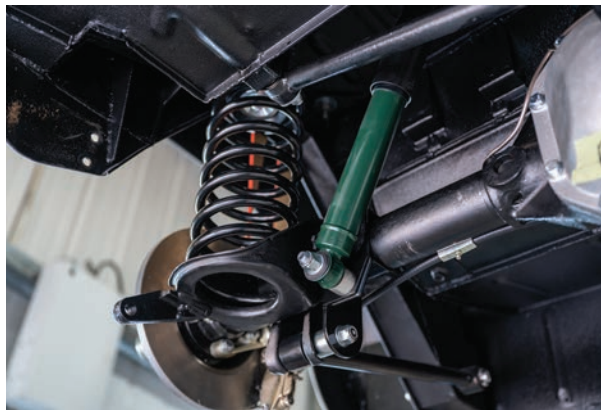
The LHD steering rack was fitted at this time with new mountings. New wheel bearings and hub assemblies were fitted with standard Girling brake callipers and new brake discs. The brake system was then connected ready for final bleeding.

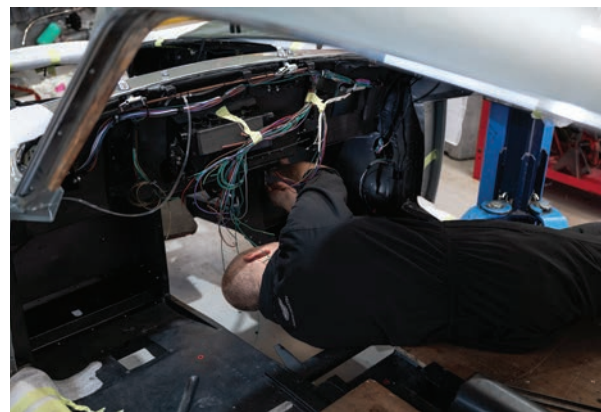
At this stage, the emphasis changed and attention was given to installing all of the behind the dashboard systems, including the electrical looms which also lead to the back of the Aston, heating and ventilation trunking, windscreen washer system and windscreen wiper motor and rack assembly.

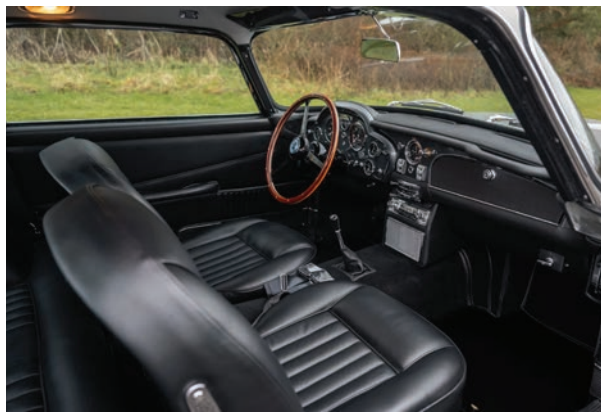
## Test and Defect Rectification

It is Aston Workshop policy that after a total restoration, any Aston being prepared must have undertaken at least 400 miles to shakedown, reveal any defects and undertake final testing and tuning. The same test program was undertaken with this Aston. No major problems were encountered and only minor adjustment to idling speed and final tune was required to create a smooth and tractable driving experience. The opportunity was also taken to adjust the electrically assisted steering to provide a comfortable degree of assistance. Final steering geometry checks and rear damper settings were made and minor adjustments implemented. There followed a full nut and bolt check of all accessible fixings. Full brake function tests were made and assessed. Finally the Aston was given a full MOT, which was passed with flying colours (as it should).
