## Restoration of the classic Aston Martin

# DB4

#### DB4/107/R

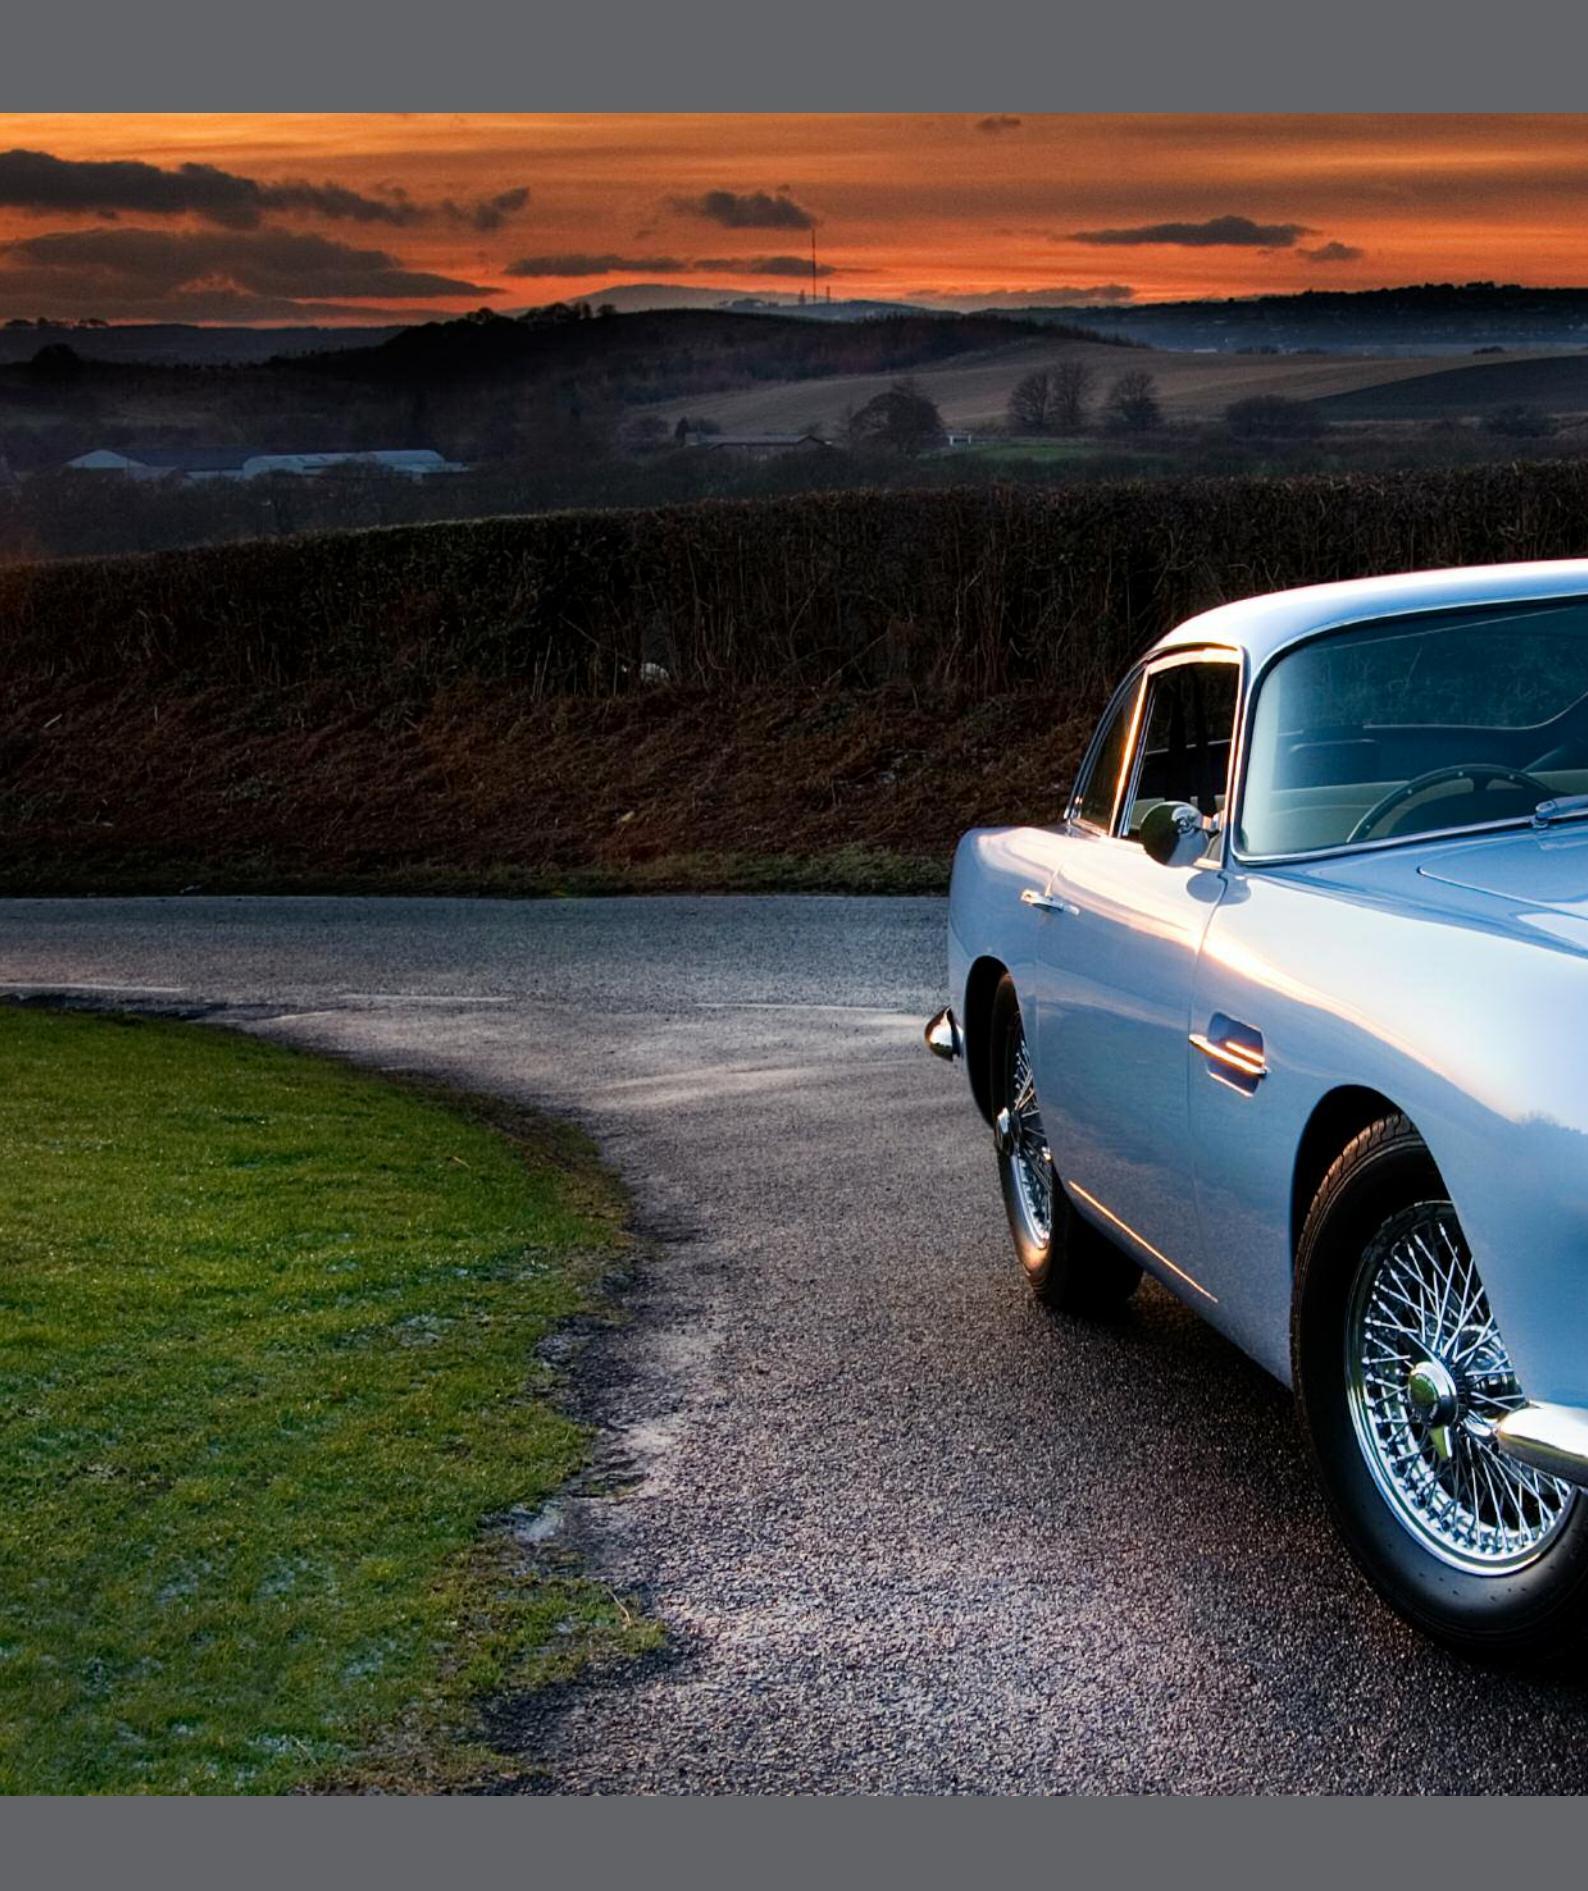
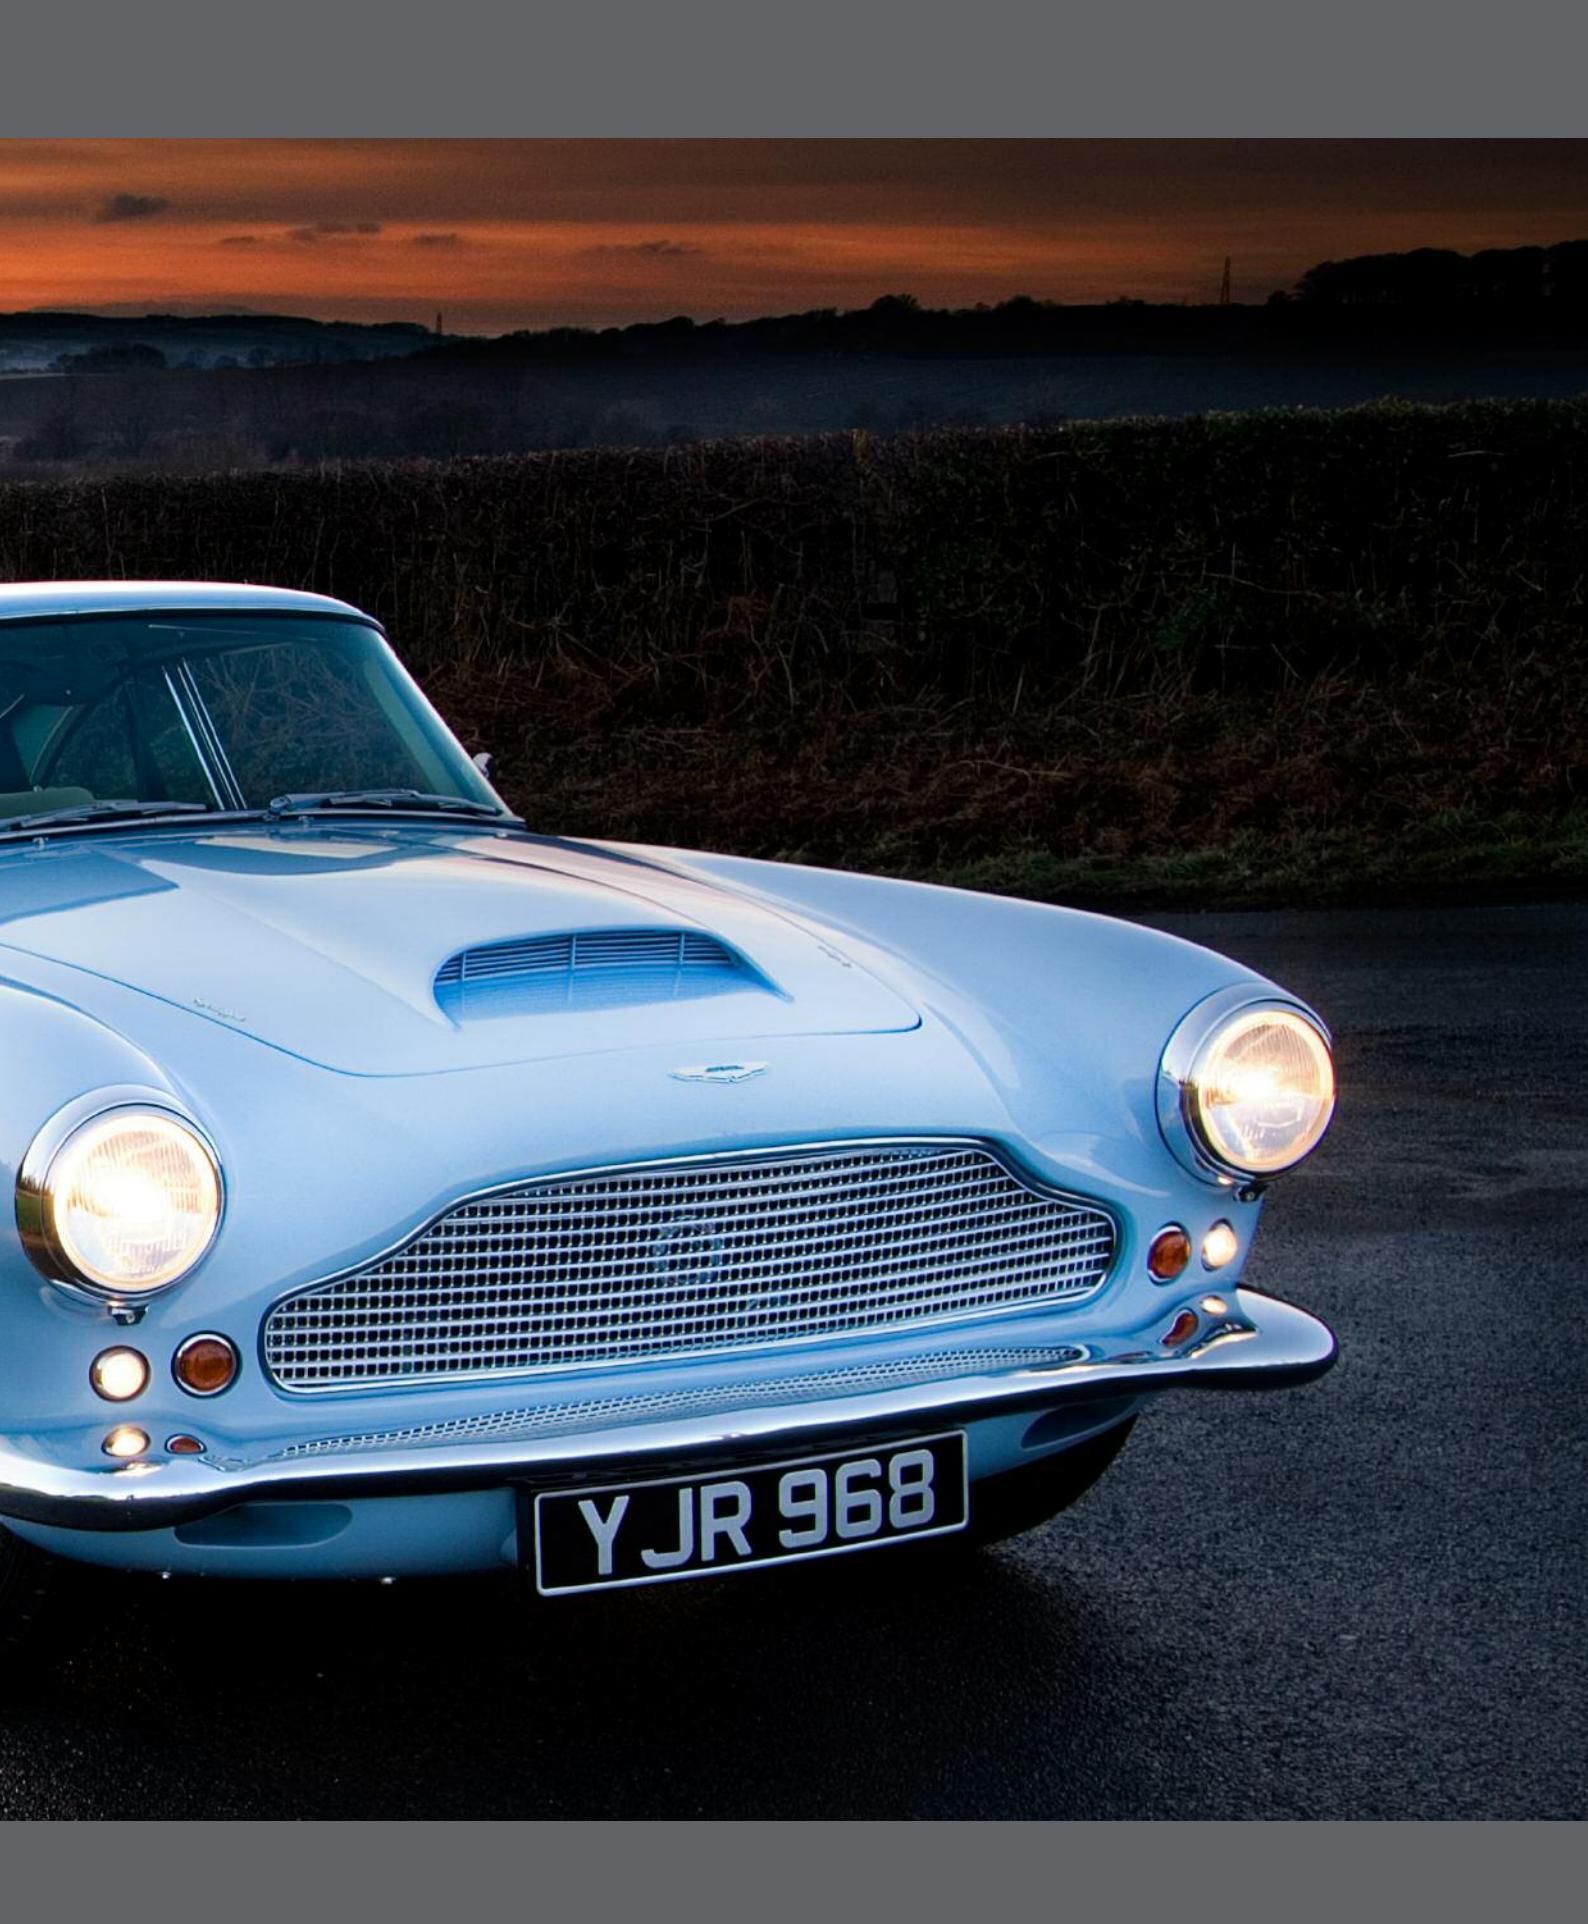
## ASSESSING THE BODY SHELL AND CHASSIS

Once this had been done, the outer aluminium sills were removed, and the chassis was then cleaned back to remove all of the residual oil, grease and general muck that had accumulated, of which there was a huge amount. This was a filthy job, but vital if the grit blast of the structure that followed was to be fully effective in removing all of the surface rust. It was only when the grit blast was completed that it became possible to acquire an indicative assessment of the chassis structure that lay underneath. Early assessments of the structure indicated that in this case, the outer forlorn state of the car was perhaps also an accurate indicator of its inner state, which was poor.

Not only were the sills showing an advanced state of decay but also the front outriggers, the rear chassis legs and a boot floor that showed more resemblance to lace than something solid. The rear suspension anchorages were equally unsound.

At the front, the base of the front footwells, the front engine bulkhead and crossmember was also heavily rust damaged, as were the under-bonnet side panels.

Stripping the many layers of paint from the outer shell followed, revealed a considerable amount of old panel damage. Corrosion in all of the usual spots was found around the wheel arches, sill, around the bonnet and across the rear of the car around the bottom of the boot, all caused through damp and the effects of electrolytic induced corrosion of the aluminium panel in the proximity of its steel supporting frame.

The doors were equally in a poor state and needed a total reconstruction. The doors on these cars suffer most from the rotting out of the door bottoms. In turn this allows the door to twist and in advanced cases, the door hinge members start to break away and the door sags. There is no other alternative to a full reconstruction, and the frame can only be completed and the door skin clenched onto the doorframe once the front and rear body skins have been repaired and remounted.

The bonnet skin also showed signs of delamination, quite common with unrestored cars, and in advanced cases, there is no alternative but to re-skin the entire bonnet. Fortunately, this proved not to be necessary with this car.

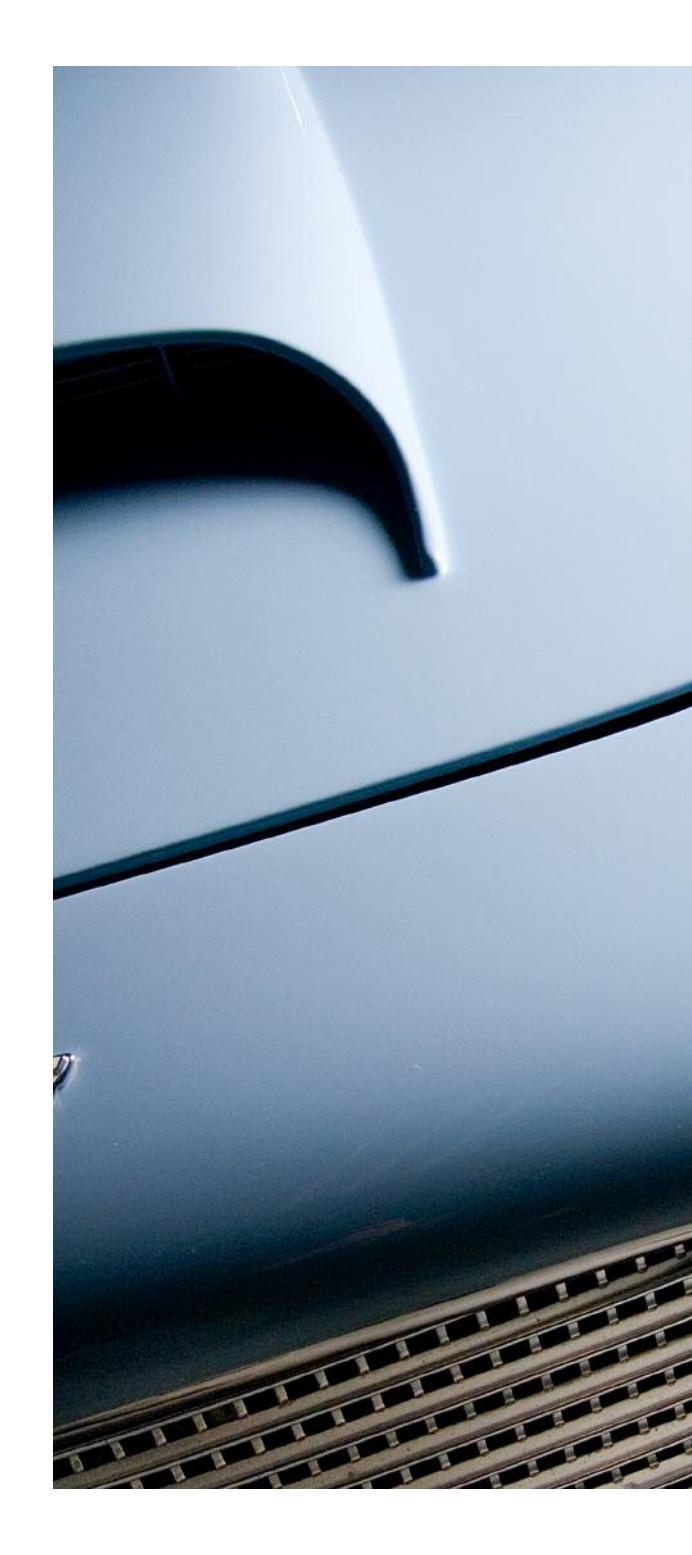
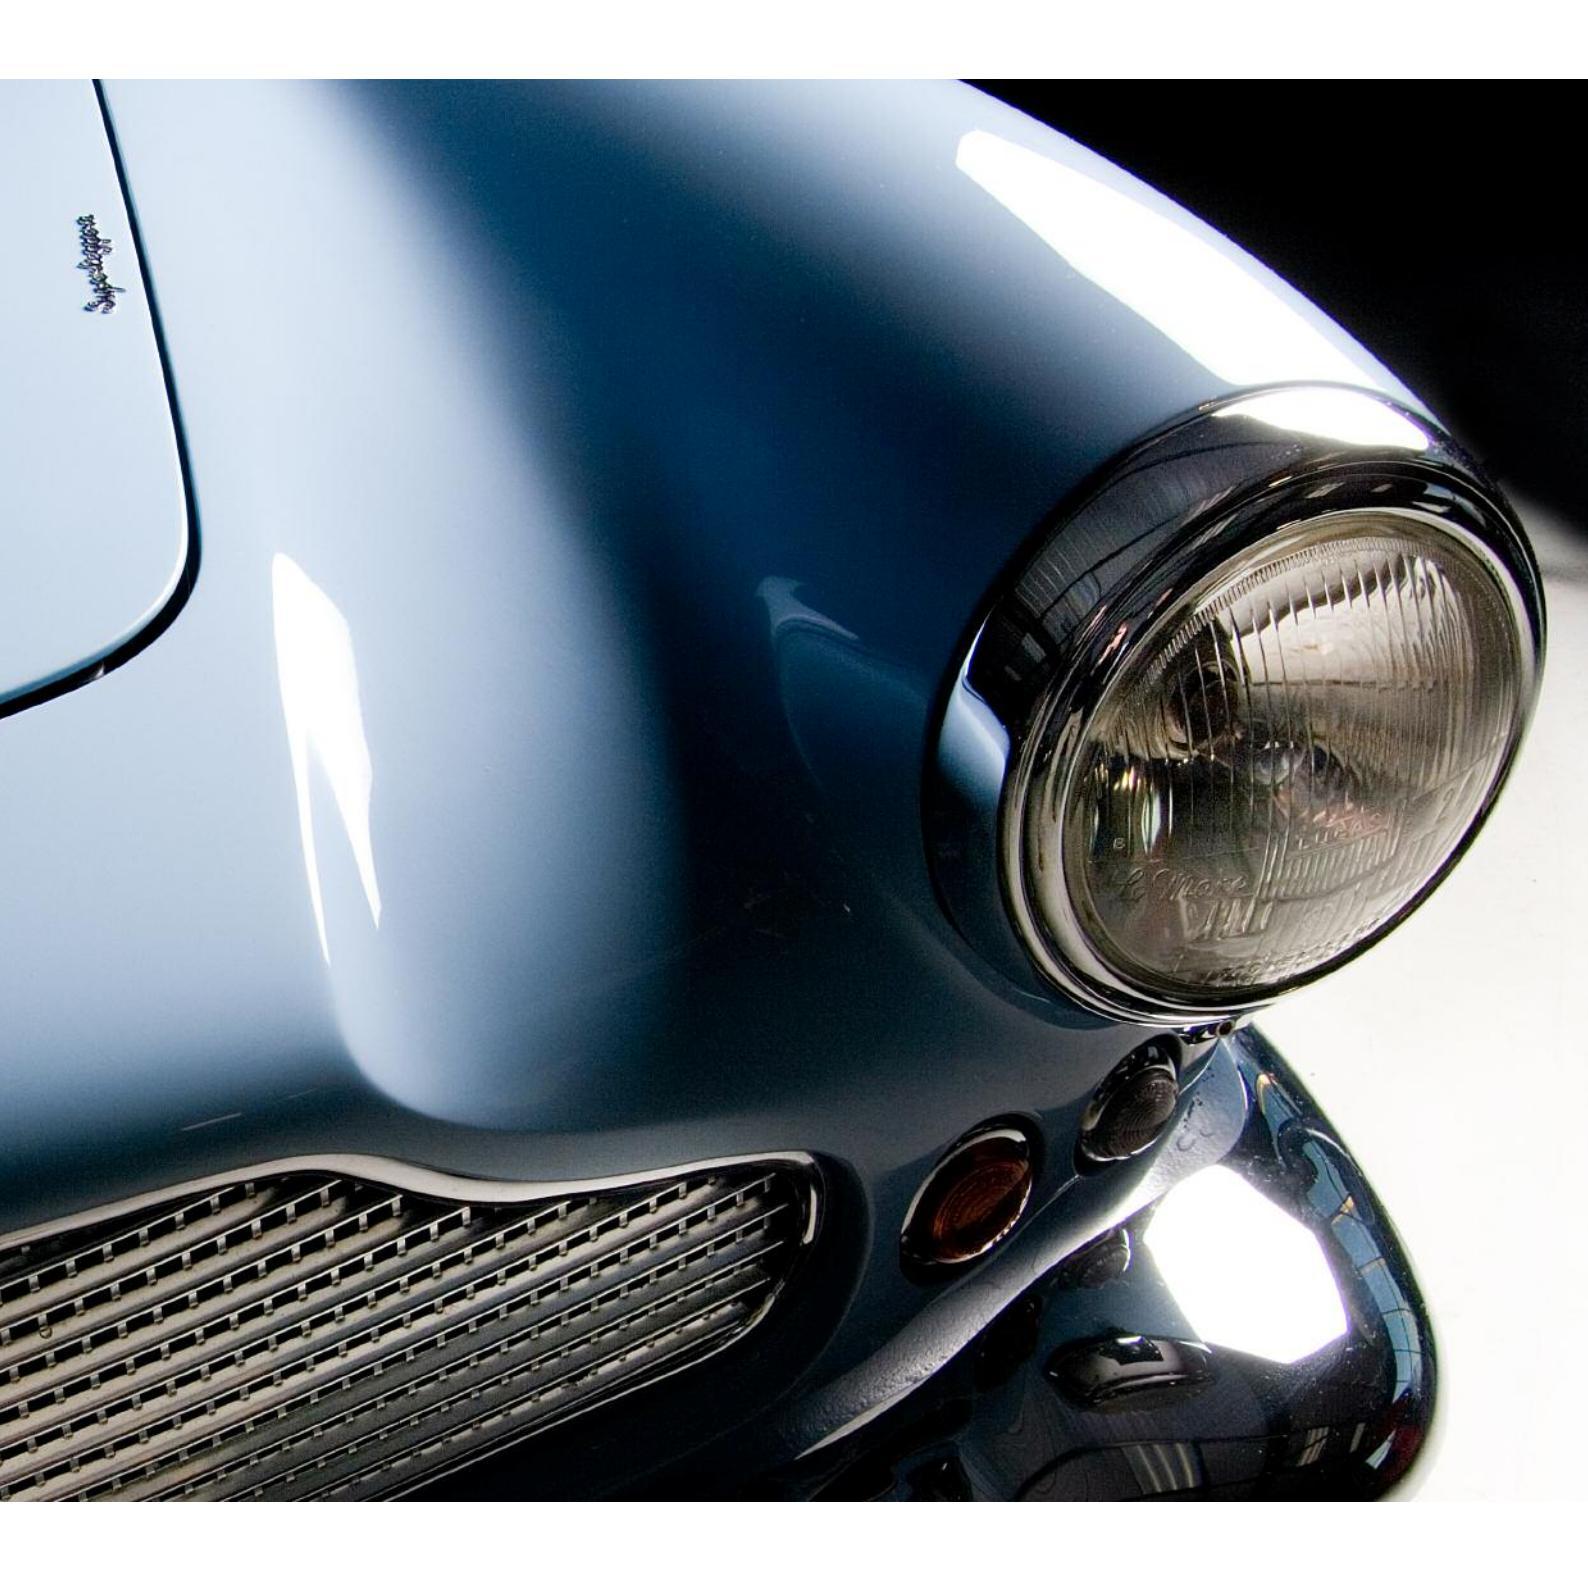
## ASSESSING MECHANICAL CONDITION

With the engine, gearbox and final drive now separated from the car, these were cleaned off and the engine was dismantled, with the first task being to remove all intake and exhaust manifolds, dynamo, water pump and fan. This was followed by the separation of the bell housing and gearbox. The next operation was the removal of the cylinder head. The sump was then removed followed by the removal of the front timing case and chain, the oil pump and filter housing. The separation of the cylinder head followed, revealing for the first time the inner state of the cylinders and pistons.

As this car was to be totally restored, the next stage was to remove pistons and connecting rods, followed by the crankshaft, oil pump and strainer assembly and all of external fittings. The cylinder block was next inserted into an oven and heated, followed by the extraction of all cylinder liners. This revealed that the seatings for the liners, though damaged, could be recovered. A check across all main bearing webs revealed no serious cracking. This meant that, subject to recovering the sound condition of the liner seatings, the block could be safely cleaned and reused.

The crankshaft was carefully measured across all main bearing and connecting rod journals, and though a small amount of wear was noted, this was well within acceptable tolerances and therefore indicated that the crankshaft could be safely reground, polished and refitted with new bearing shells.

The cylinder head was also dismantled at this stage, revealing no particular problems. Waterways were flushed out, valve guides extracted, the cylinder head heated and the old valve seats removed. All external fittings were removed as a matter of course and set aside for later examination. Apart from removing the hubs and suspension fittings, the rear axle was cleaned and set aside for reconditioning, as was also the 4-speed gearbox. Brake calipers were dismantled and stored in readiness for reconditioning. All other brake components were then scrapped as a matter of course.

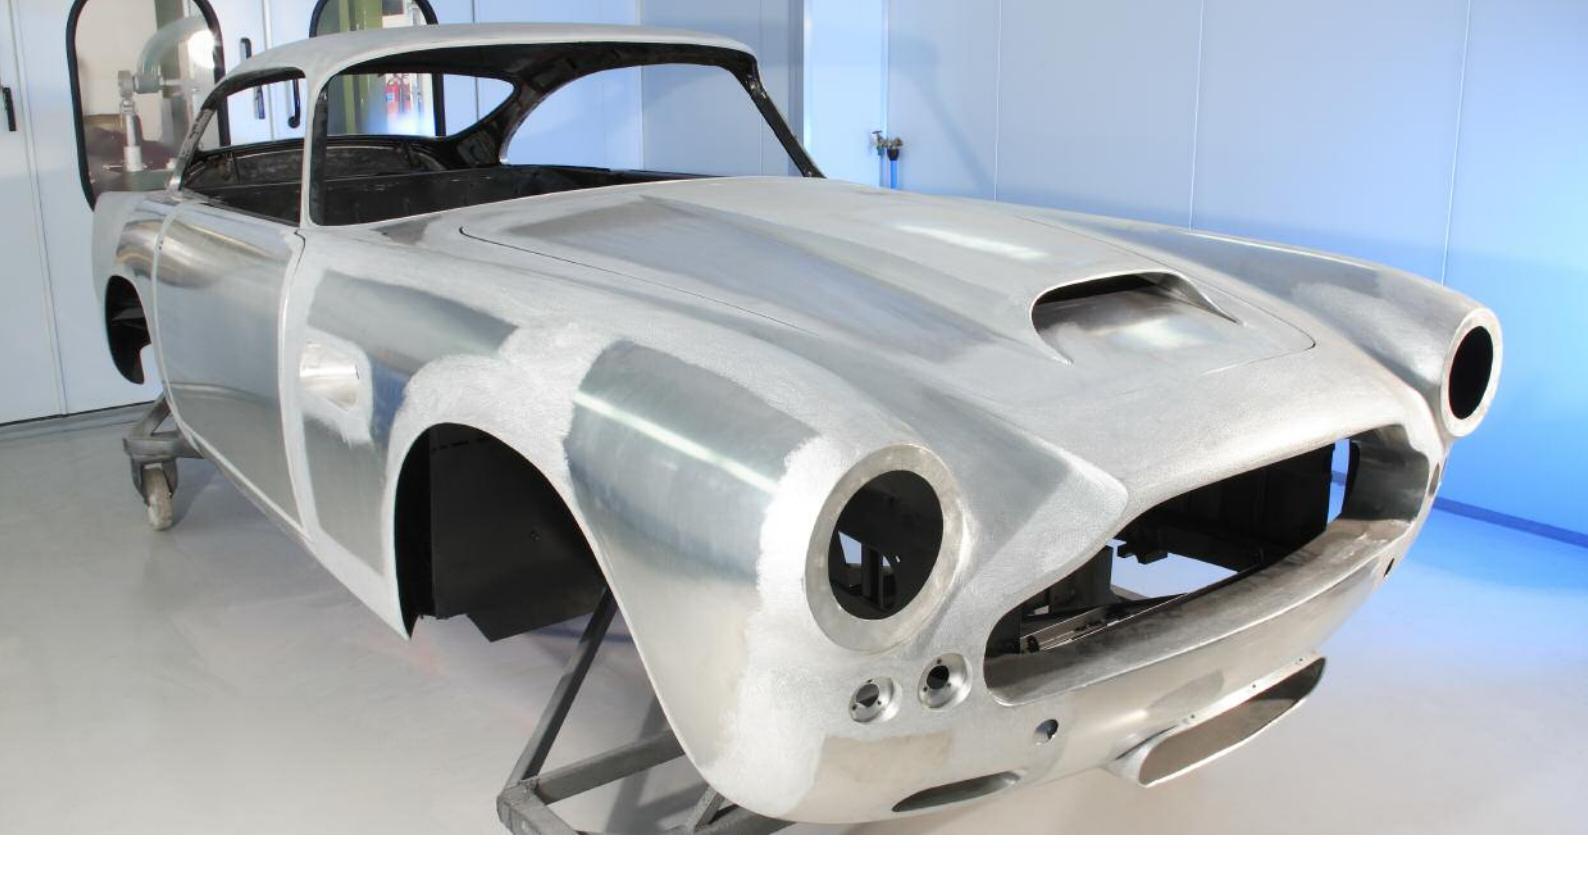
The chassis reconstruction involved repairs to almost every section and panel below the top of the A and B posts. Important structures replaced in toto involved the sills, both front outriggers, large sections of the chassis leading back from the front crossmember and which supports the front suspension and new jacking points. At the rear, virtually the complete rear suspension supporting structure required to be replaced, as well as the support legs leading backwards to support the boot floor. Within the bonnet area, not only did the panels either side of the bonnet need replacement, but also all of the forward structure from the front suspension uprights back to the engine bulkhead. Sections of the front bulkhead showed significant deterioration and rust damage and areas had to be cut out and replaced. All of the floor sections had to be replaced and welded into place, as also the rear seat pan, which had been holed.

In all, the extensive level of reconstruction involved some 700 hours of skilled fabrication as every new section had to be shaped to fit and carefully welded into place. Once the reconstruction was completed, the finished chassis was again grit blasted and then primed and powder coated, giving a hard, durable and impervious satin black coating to the chassis. All of the internal surfaces were primed and painted prior to assembly. Once the structure had been powder coated, all of the internal sections were then wax injected, thus providing a significantly enhanced level of corrosion protection.

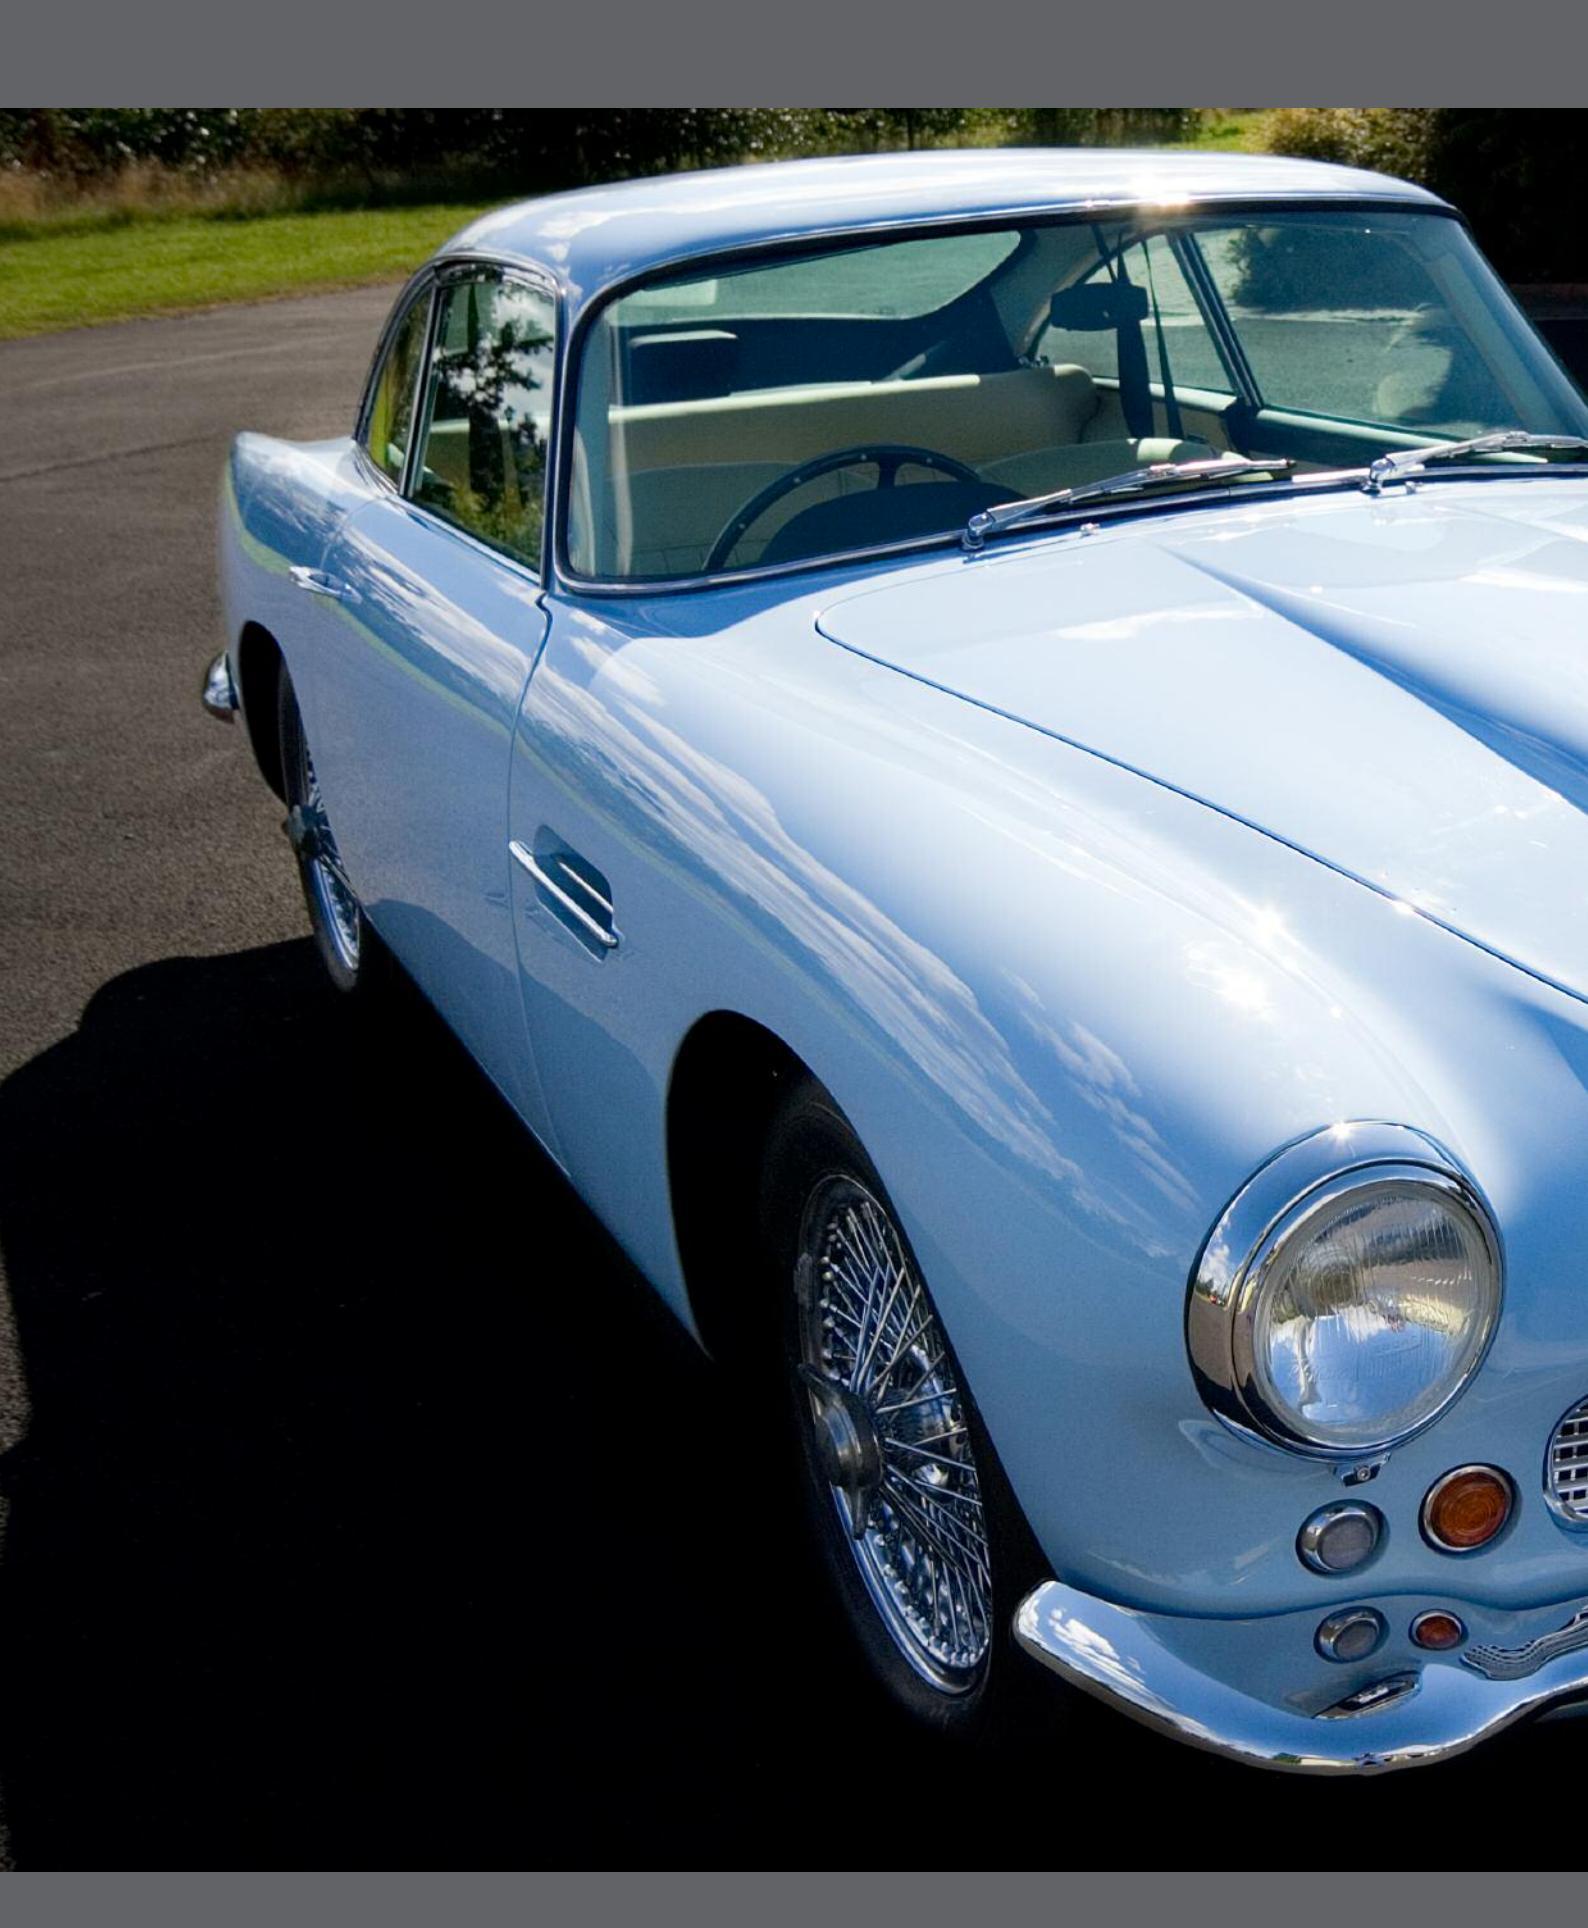
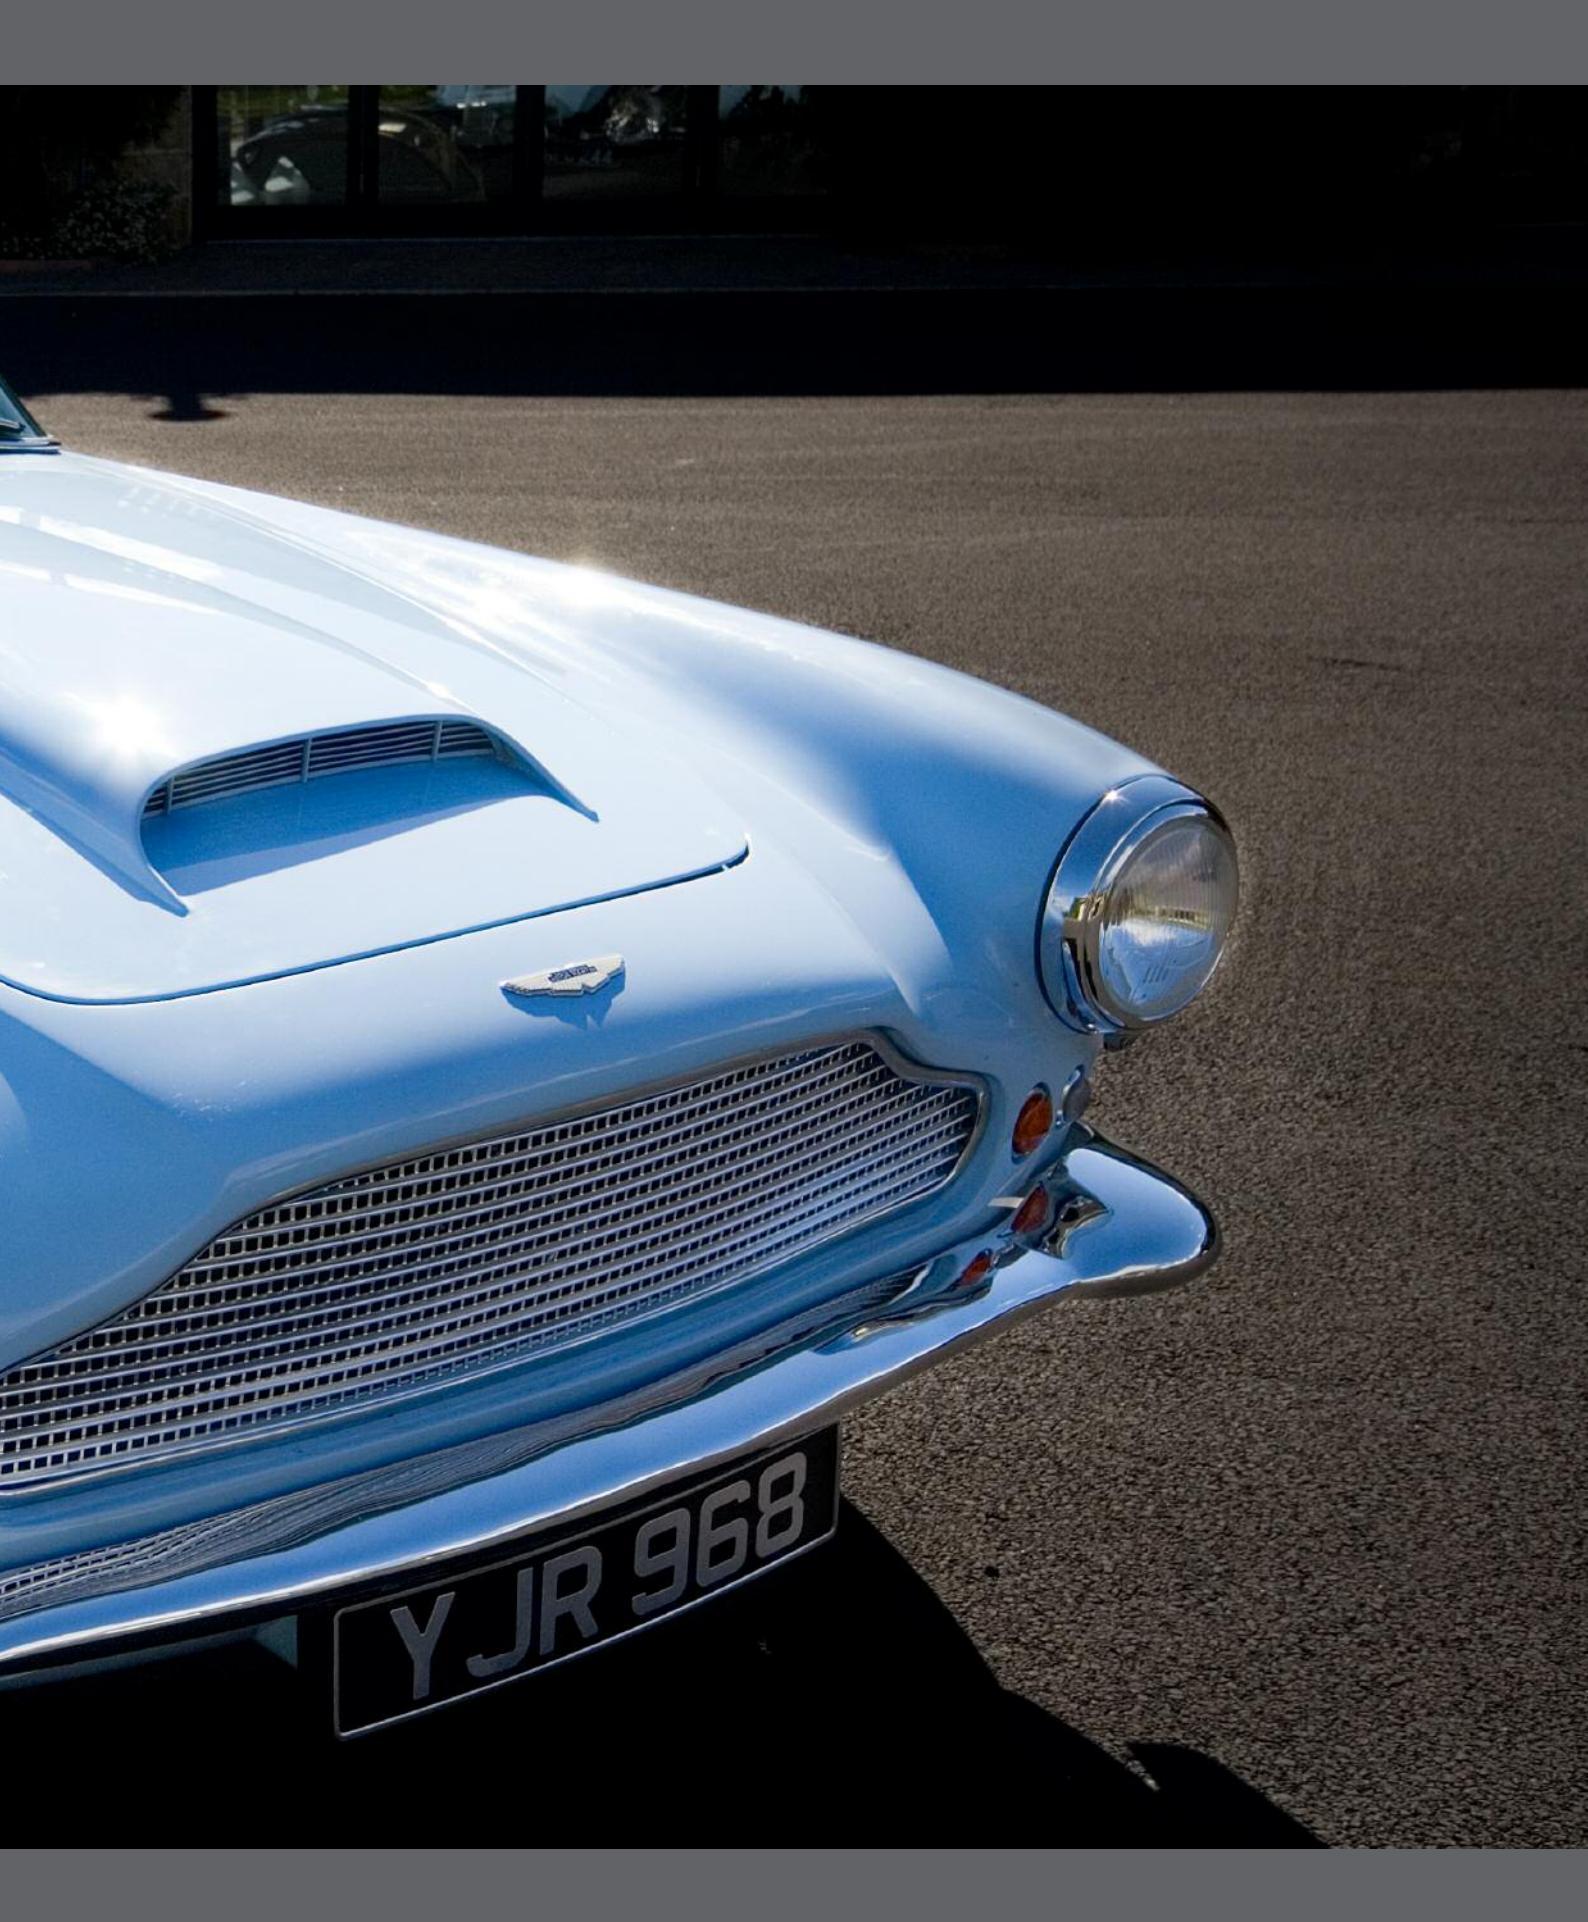
### **BODY SHELL FABRICATION**

In keeping with the Aston Workshop restoration policy, it was usual to renew the body shell, front and rear, and to fit this to the restored chassis. In keeping with this policy, DB4/107/R was duly dispatched to a partner company, Shapecraft, for the new shell to be fitted and shaped, modifying as required to ensure perfect alignment with the roof section and main structural sections of the chassis, these being the sills, A and B posts, bonnet aperture, windscreen frame, rear window frame, and boot aperture. The door frames were reconstructed in their final state, once the front and rear shells had been fitted and aligned, thus ensuring perfect door alignment and they were then re-skinned and trimmed to fit.

Once the new shell had been fitted, there was then the highly skilled task of finally shaping the outer panels to ensure a perfectly smooth surface for priming and painting. The shell was subsequently painted in its final shade of Wedgwood Blue, and given its final rub down and polish to achieve a perfect mirror smooth finish. Six months after dispatch, DB4/107/R was received back as a fully completed and painted body shell with doors, boot and bonnet all fitted, ready for reassembly into a complete car.
